# Inspection Report

Derek A. Porter NACHI25090320  
American Dream Property Inspection Service  
(619) 517-3029  
propertyevaluations@gmail.com  
Serving All Of Southern California

Sample Property

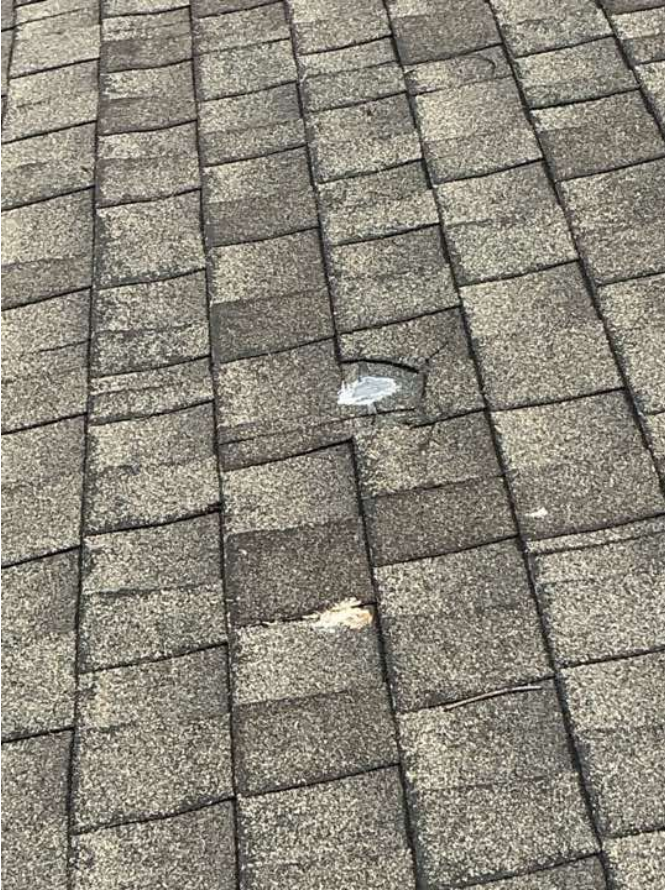
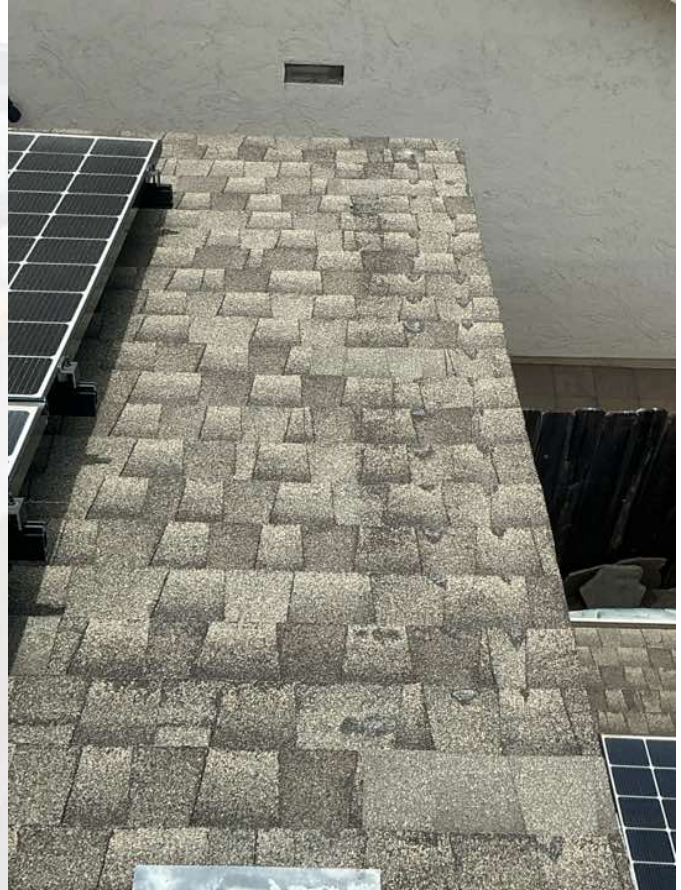
**MED 33:** Portions of the surface granulation are deteriorated and there are minor surface cracks developing. These are normal signs of aging and no action is needed at this time.

**MED 34:** One or more roof shingles were damaged on the roof. Damaged shingles can allow moisture intrusion and may lead to deterioration of the underlying roofing materials. Recommend repair or replacement of the damaged shingles by a qualified roofing contractor.

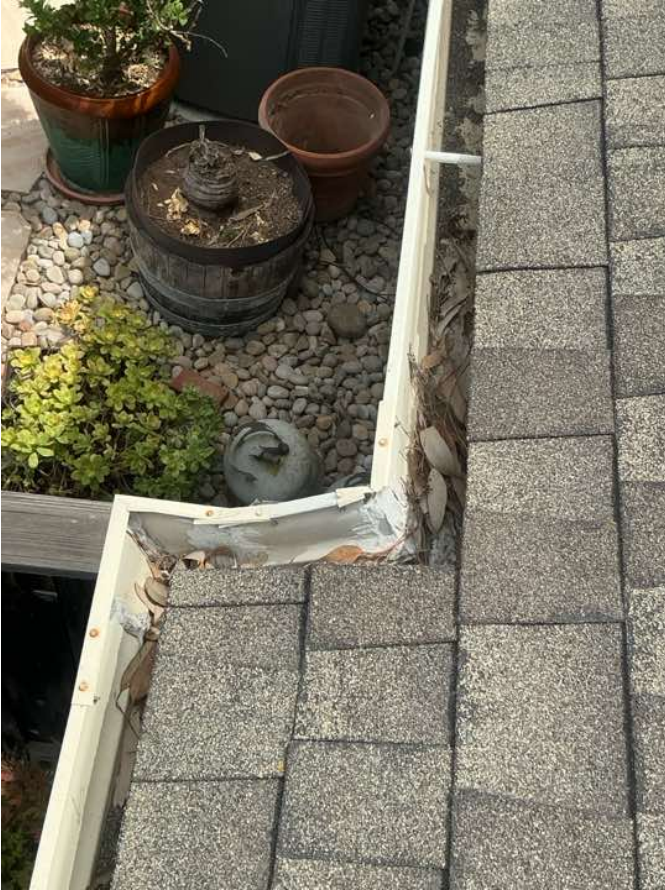
**MIN 36: Gutters Debris Accumulation (Maintenance Recommended)**

The gutters were observed to be filled with debris and pine needles. Accumulated debris can restrict proper drainage, leading to overflow, water intrusion, and potential damage to fascia, siding, and the foundation.

Recommendation: Clean the gutters and downspouts to ensure proper water flow and continue routine maintenance, especially during and after the fall season.

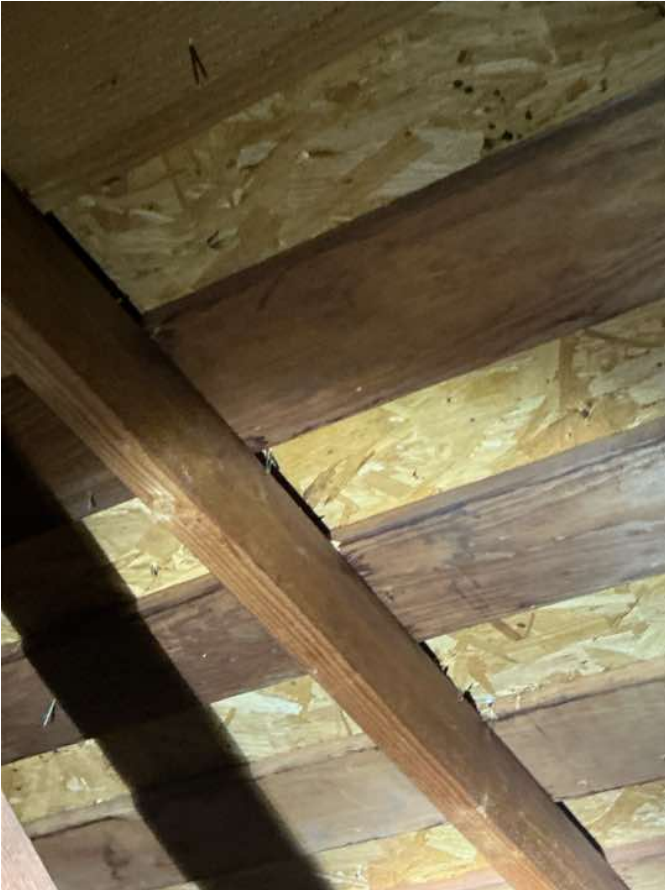
**MIN 38:** There are water stains on the underside of the sheathing and the rafters. These are indications of old leaks. No current leakage is evident or suspected. No action is indicated.

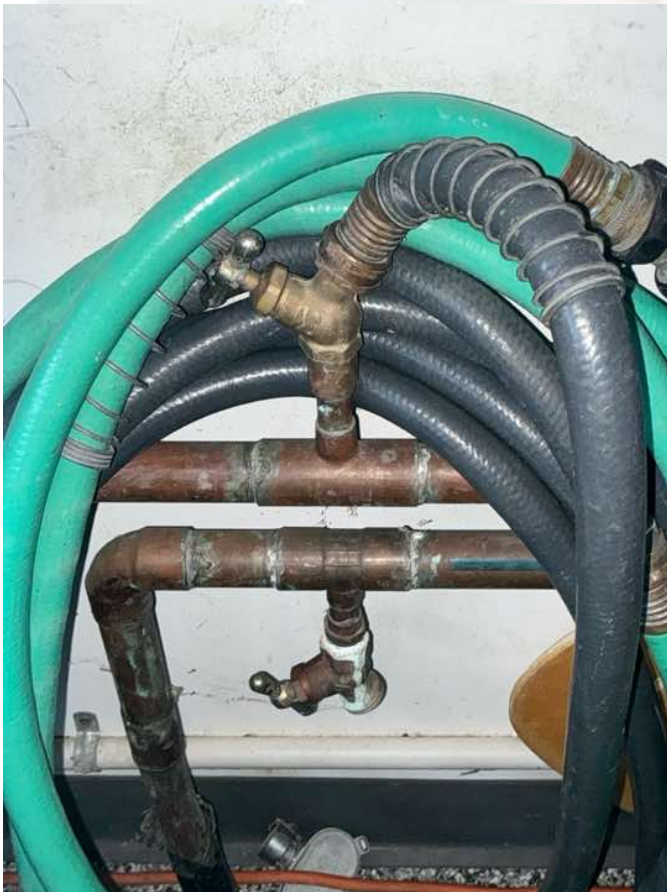
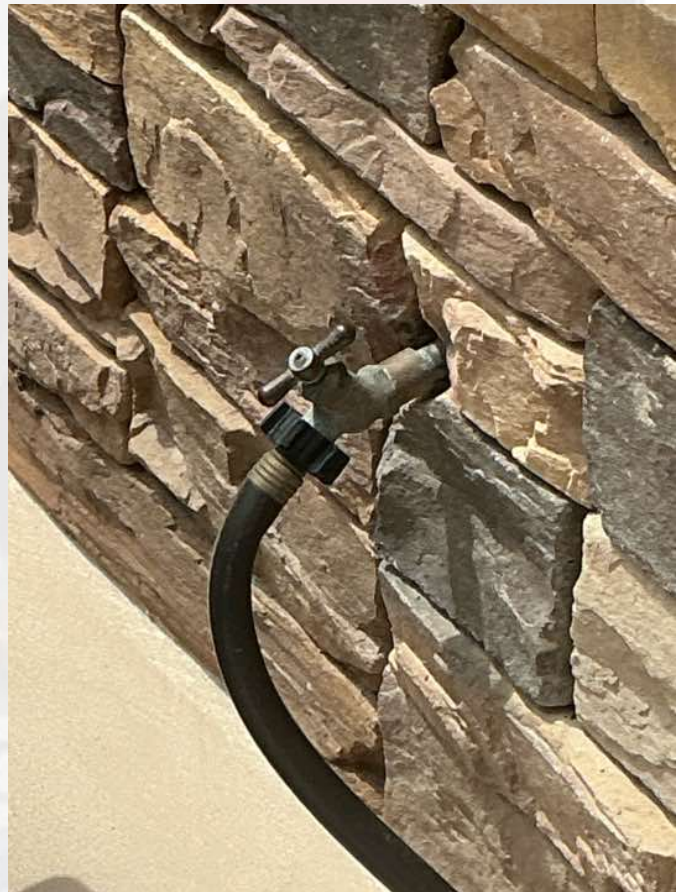
**MIN 44:** Backflow prevention devices are now required on exterior hose bibs to prevent contamination of the domestic water supply. These devices are inexpensive and available at most hardware stores. Upgrading the hose bibs should be considered.

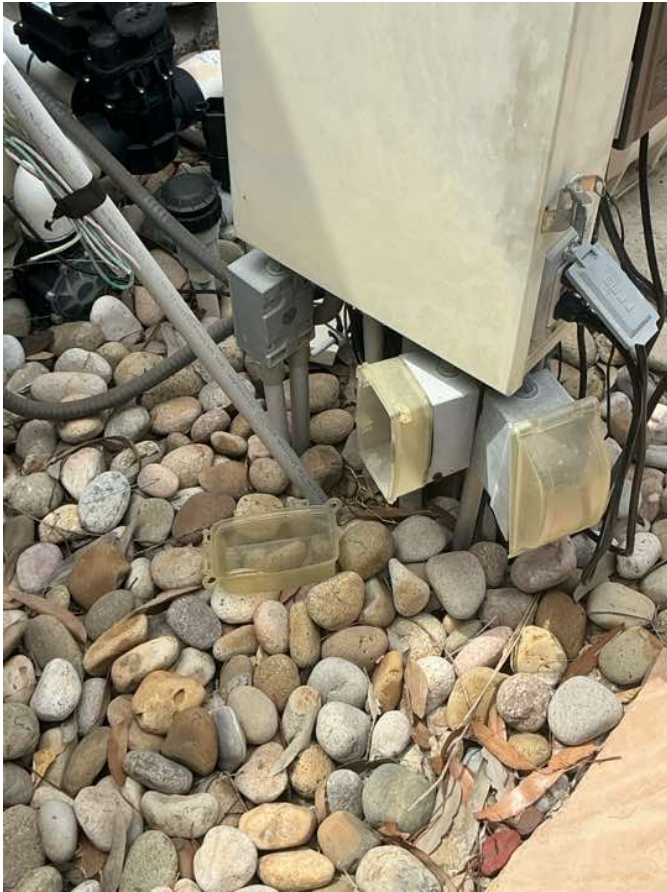
**MED 45:** A receptacle cover plate at the pool equipment is damaged. We recommend it be replaced during the course of normal maintenance.

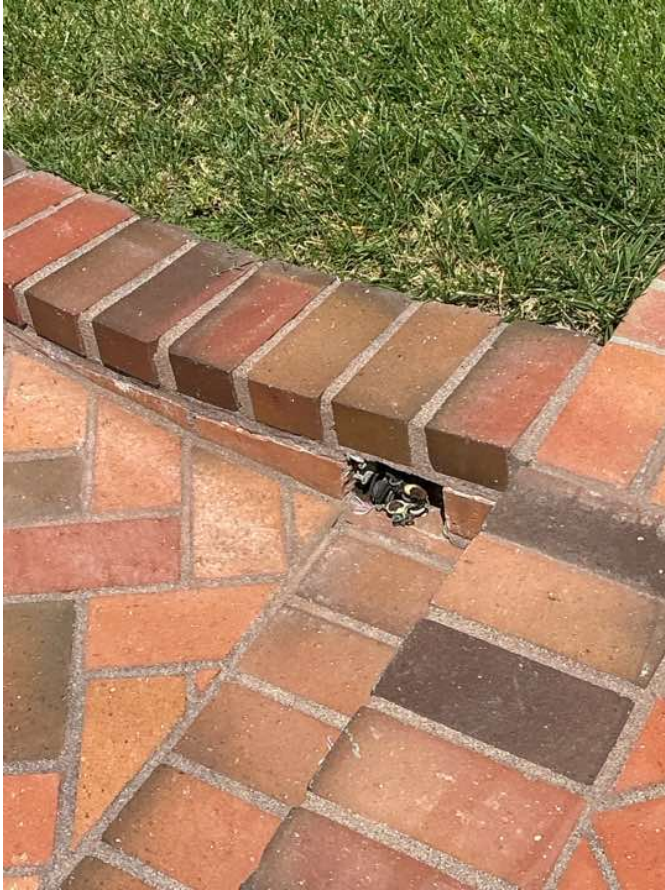
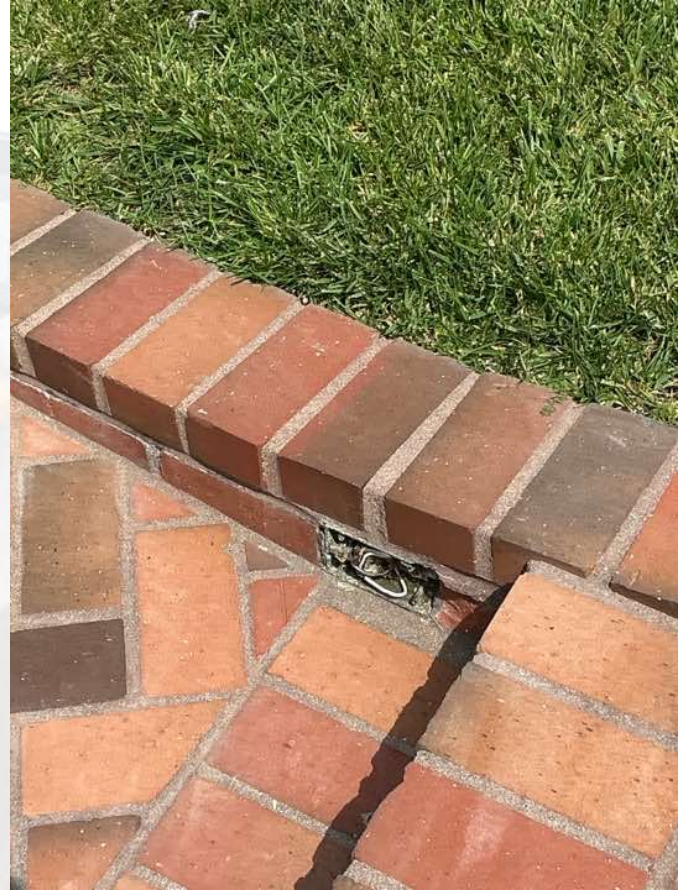
**MED 46:** The light fixtures at the front steps are damaged. We recommend they be repaired or replaced.

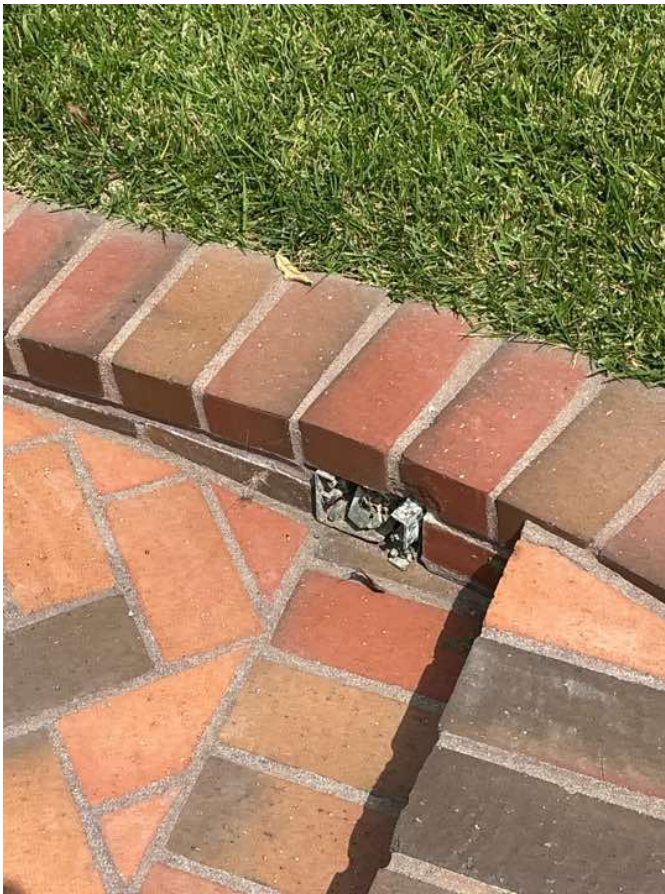
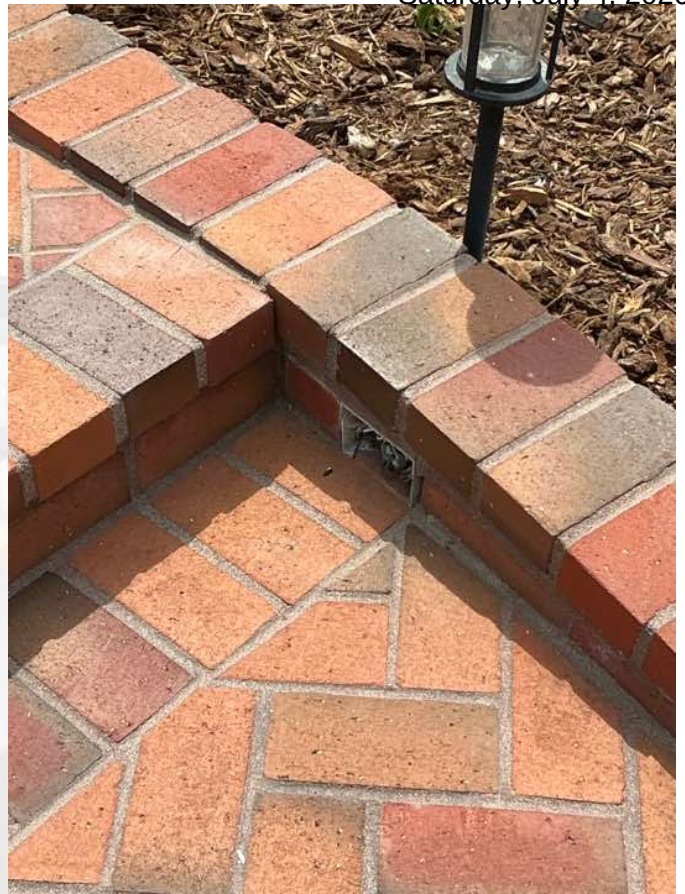
**MED 47:** A fixture is missing at the rear patio. We recommend the fixture be installed for proper lighting.

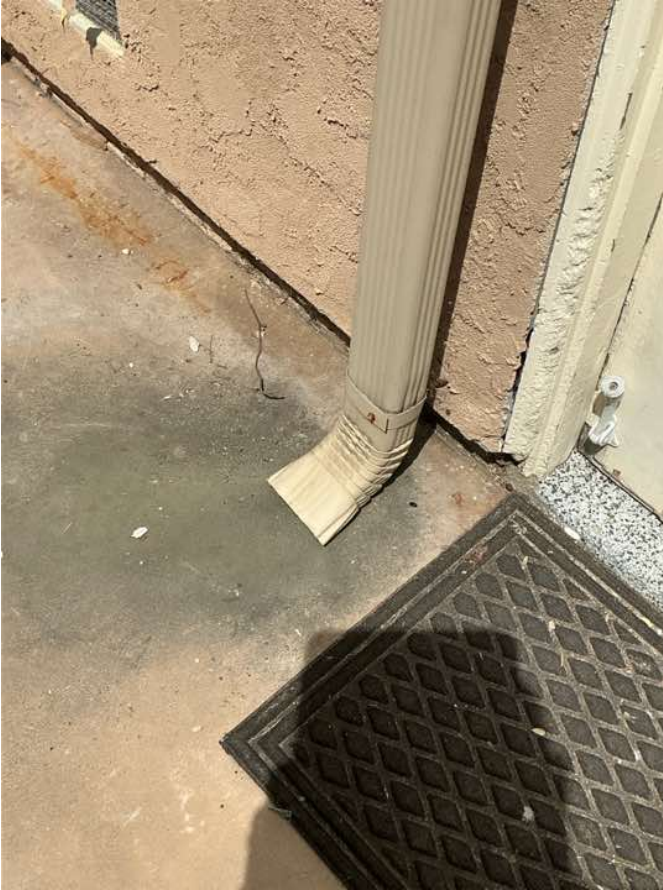
**MED 48:** Runoff water from the roof discharges next to the structure. We recommend the downspouts be routed sufficiently away from the structure to prevent puddling, pooling, and saturation of the soil around the building.

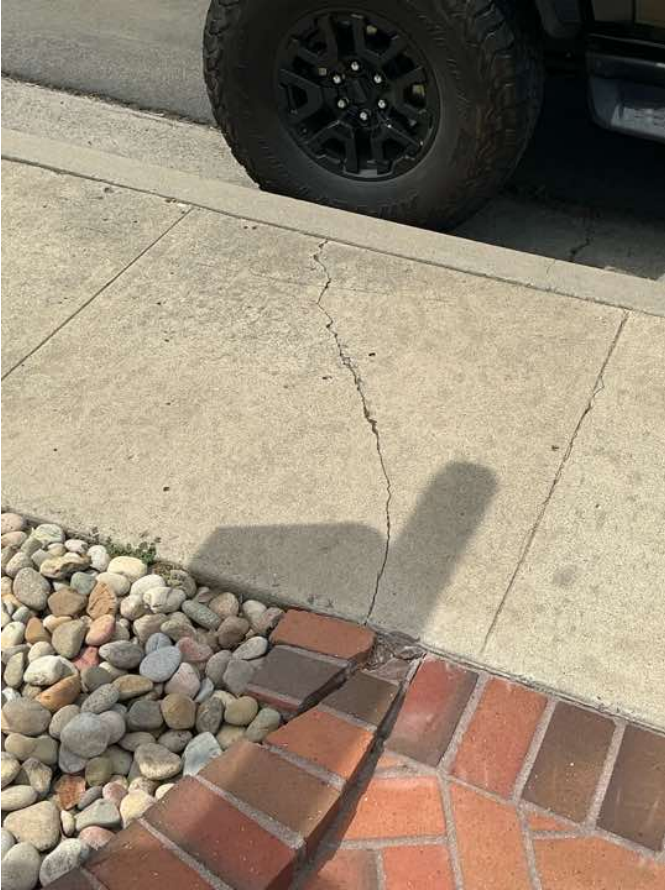
**MIN 49:** There are minor cracks of a cosmetic nature in the public sidewalks. Action would only be required if any of the cracks develop into trip hazards in the future.

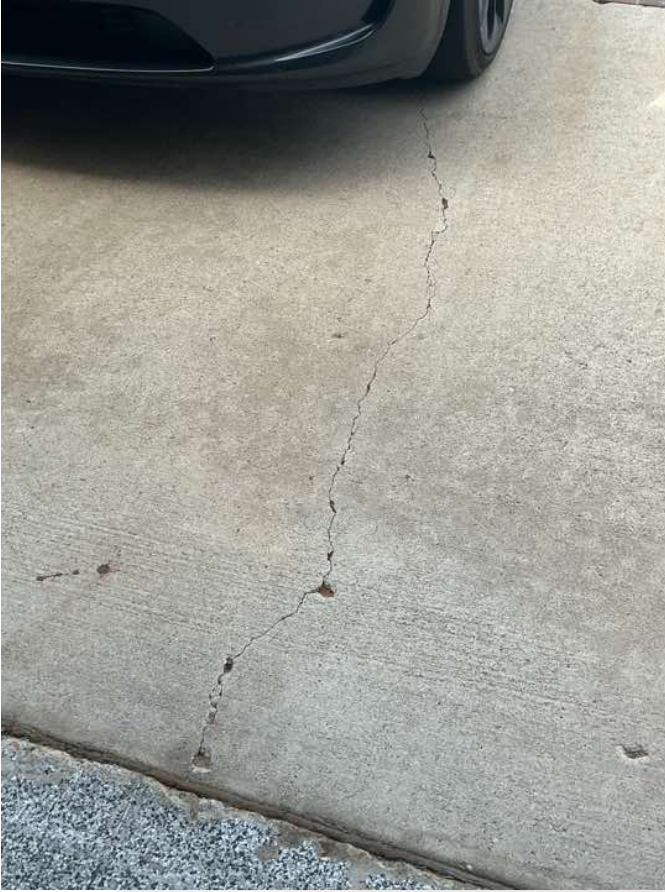
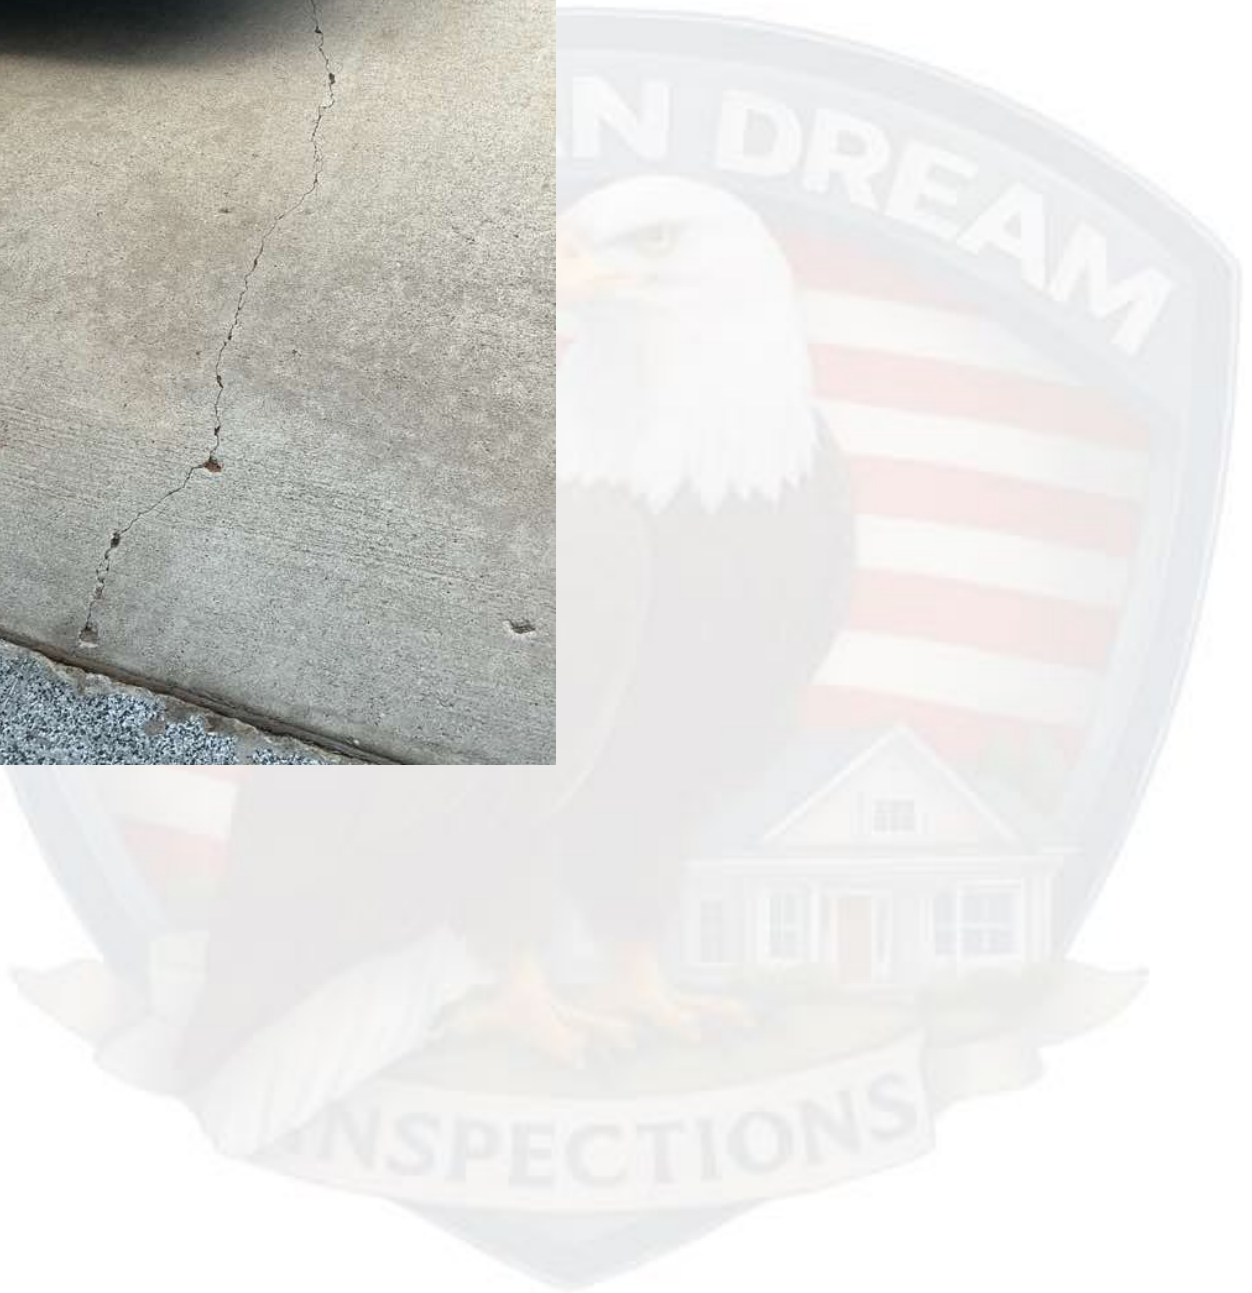
**MIN 50:** The minor cracks in the driveway are of a cosmetic nature only. No action is indicated.

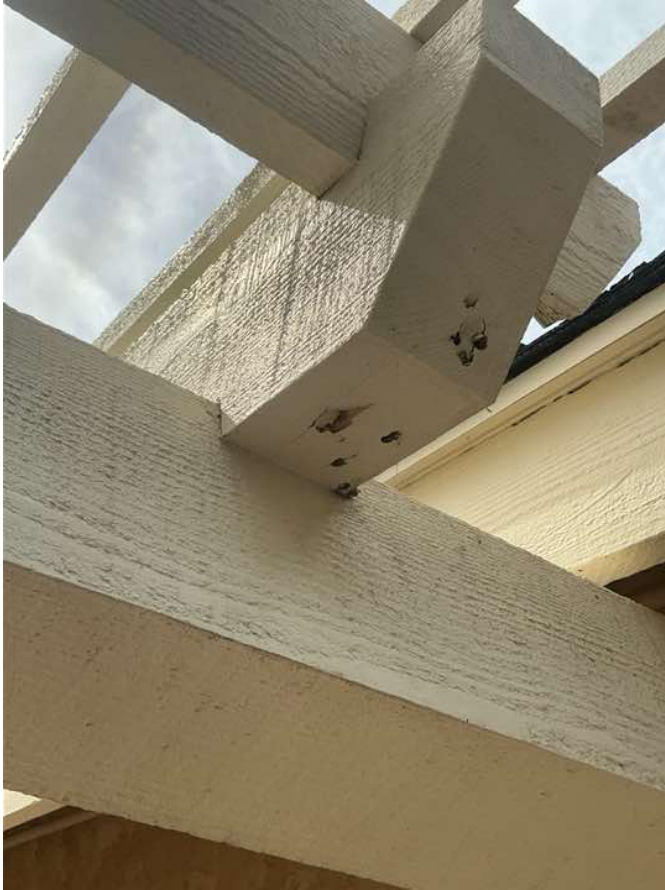
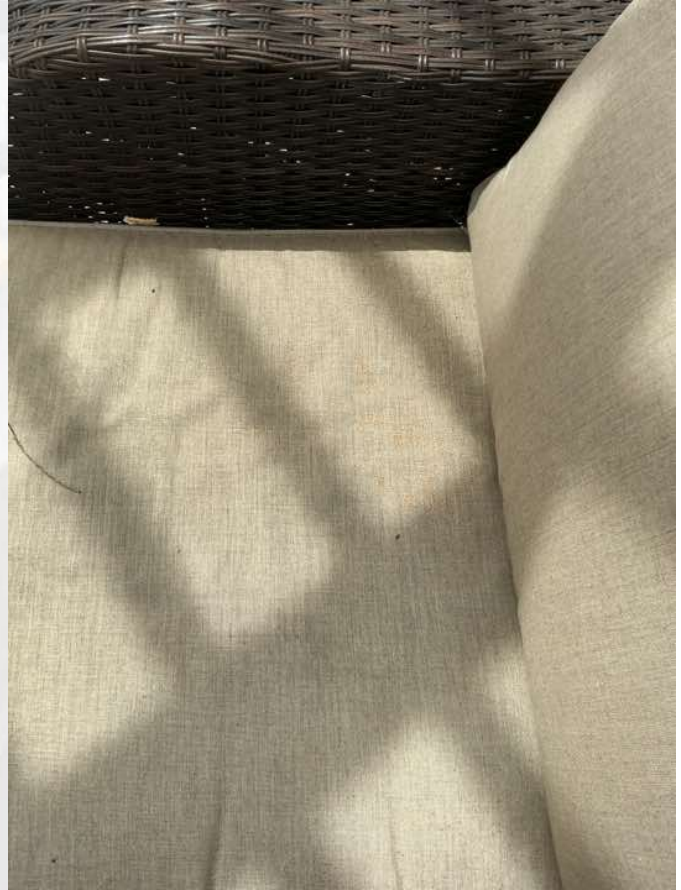
**MED 51:** Evidence of wood-destroying organism activity, including termite damage and frass, was observed at the patio cover. The affected wood may have reduced structural integrity, and concealed damage may be present. Recommend evaluation by a licensed pest control company and repair or replacement of damaged wood as necessary by a qualified contractor after treatment.

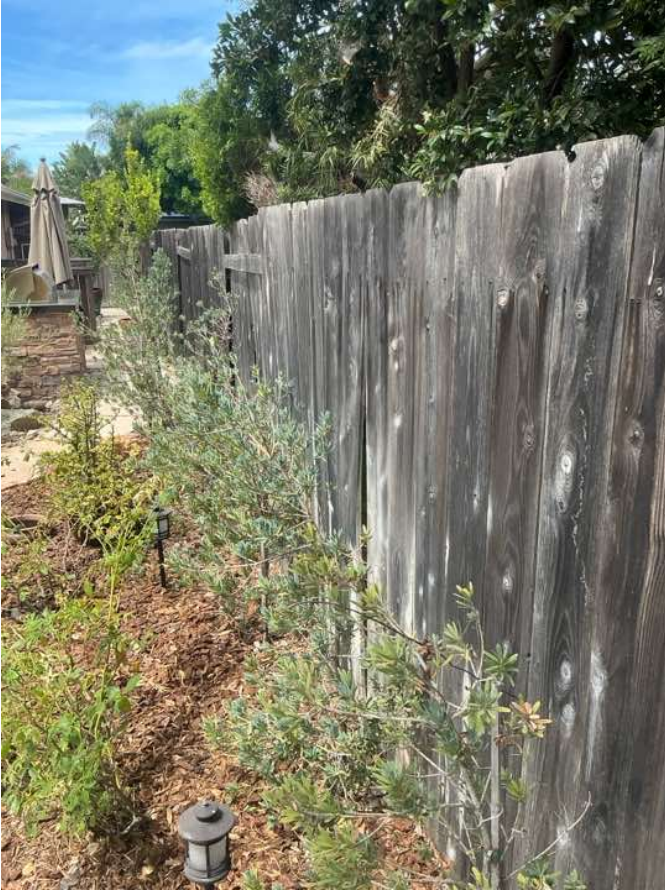
**MIN 52:** The fencing is generally serviceable but shows signs of routine wear and is in need of minor maintenance.

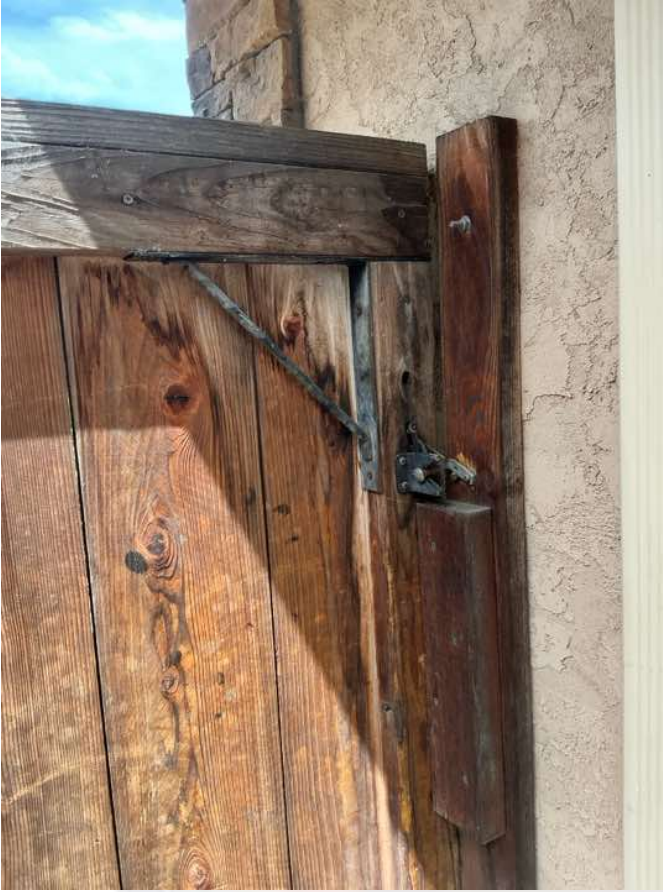
**MED 53:** The gate at the front right is difficult to operate and does not self latch. We recommend repair or replacement.

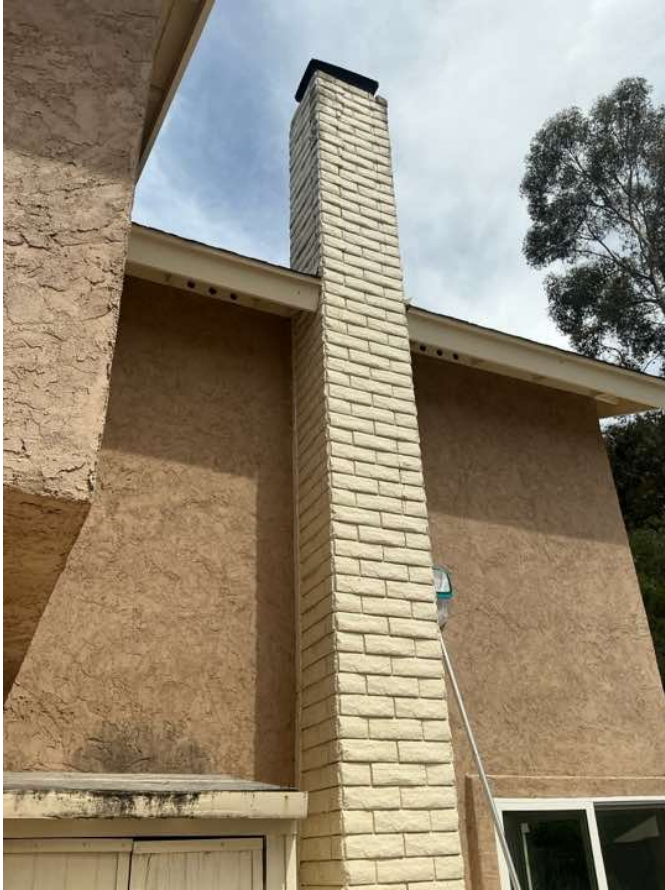
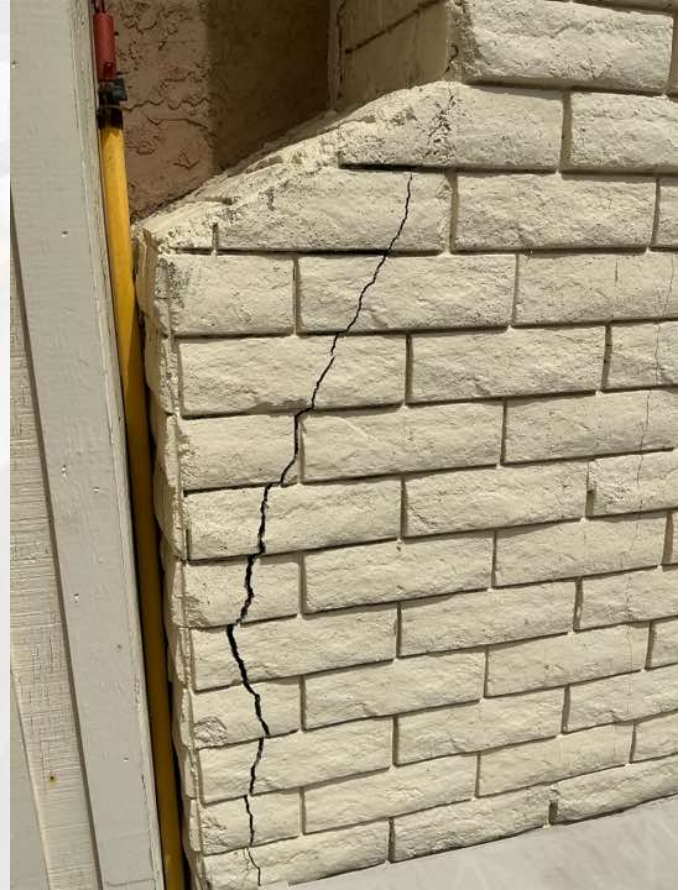
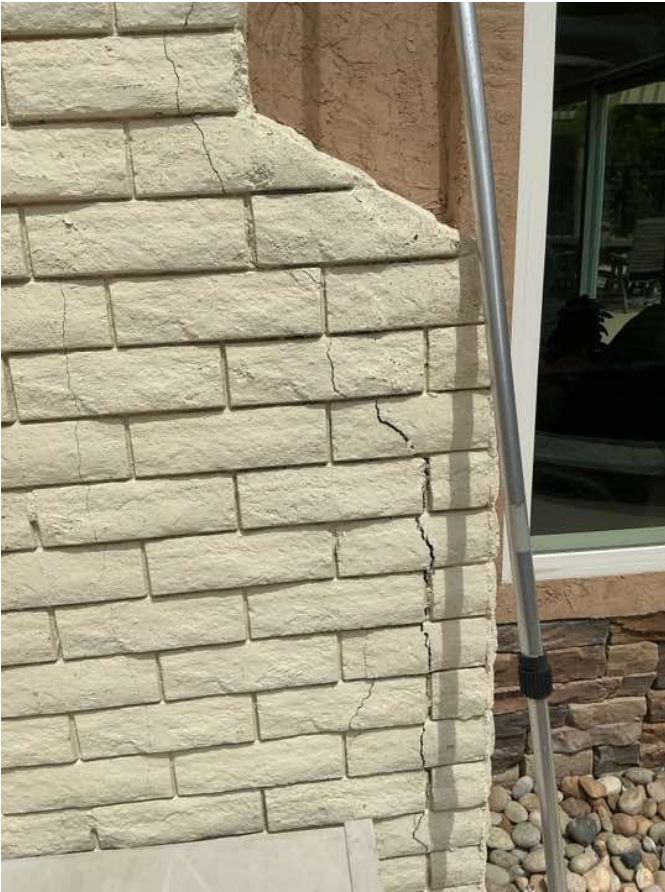
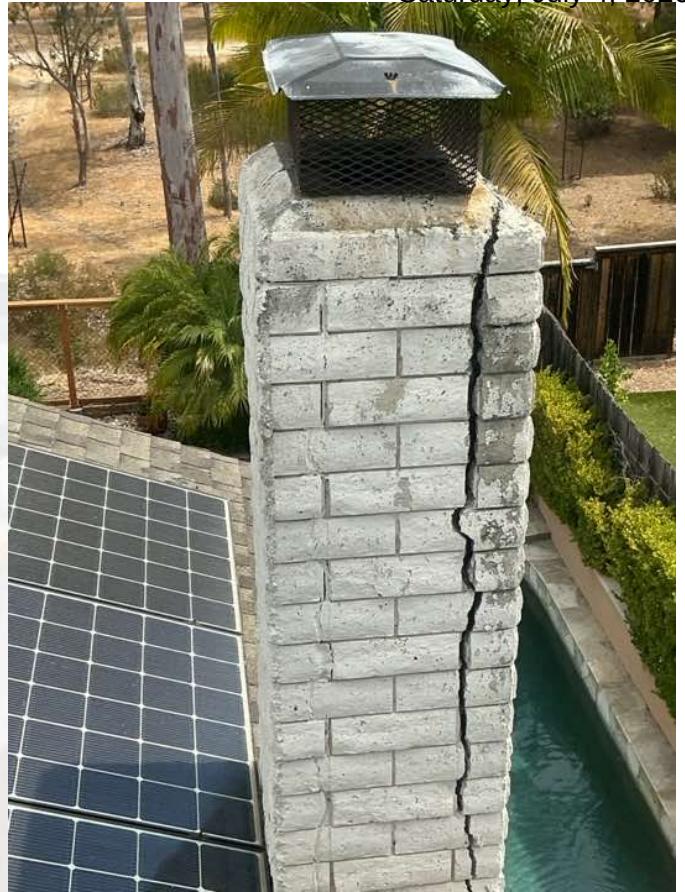
**MJR MED 55:** Cracking was observed in the Rampart General precast concrete chimney. Cracks in precast chimney components can permit moisture intrusion, accelerate deterioration, and may affect the performance of the chimney system. Recommend evaluation and repair by a qualified chimney contractor in accordance with the manufacturer's recommendations.

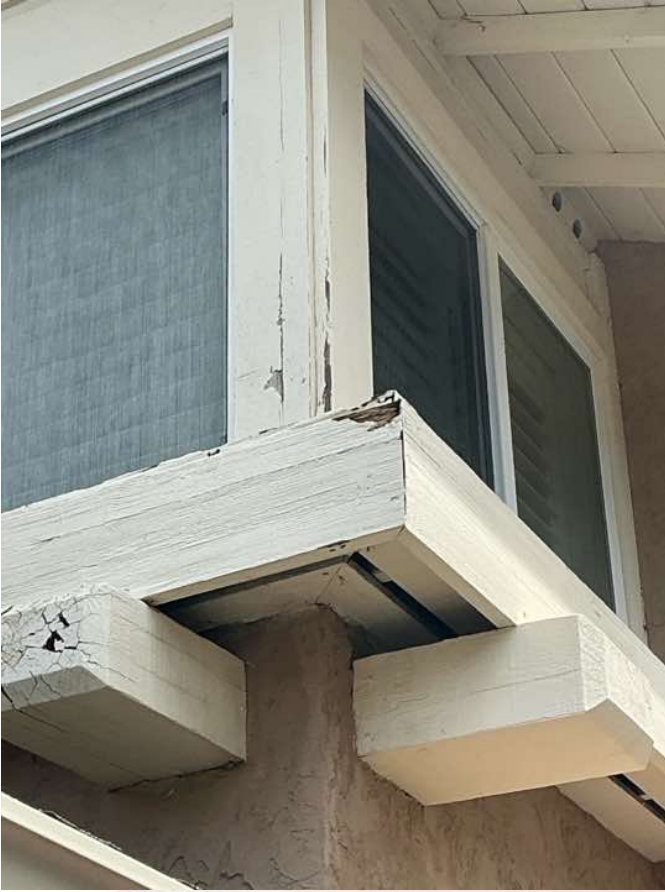
**MED 56:** The trim at the window ledges is deteriorated. We recommend it be repaired or replaced.

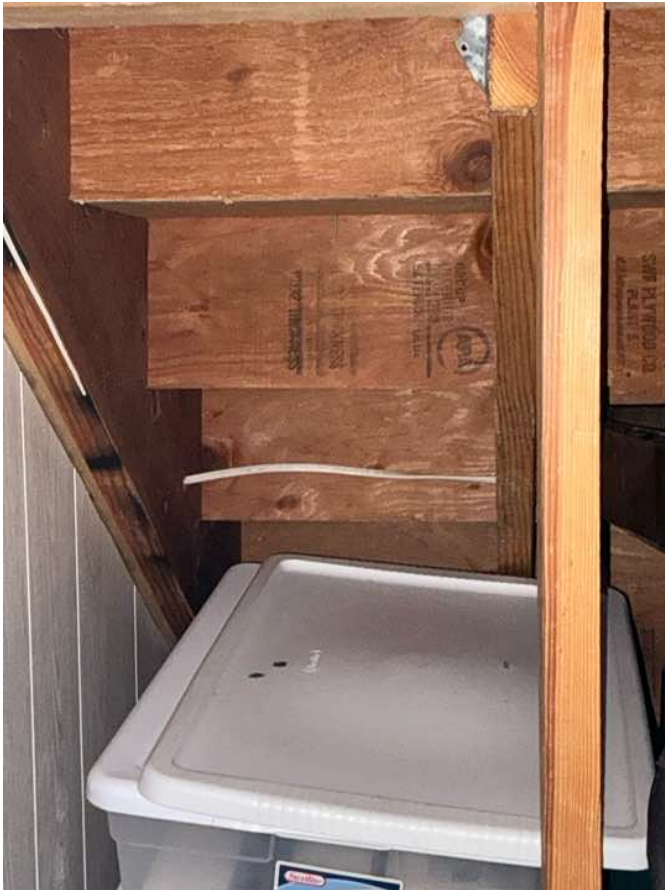
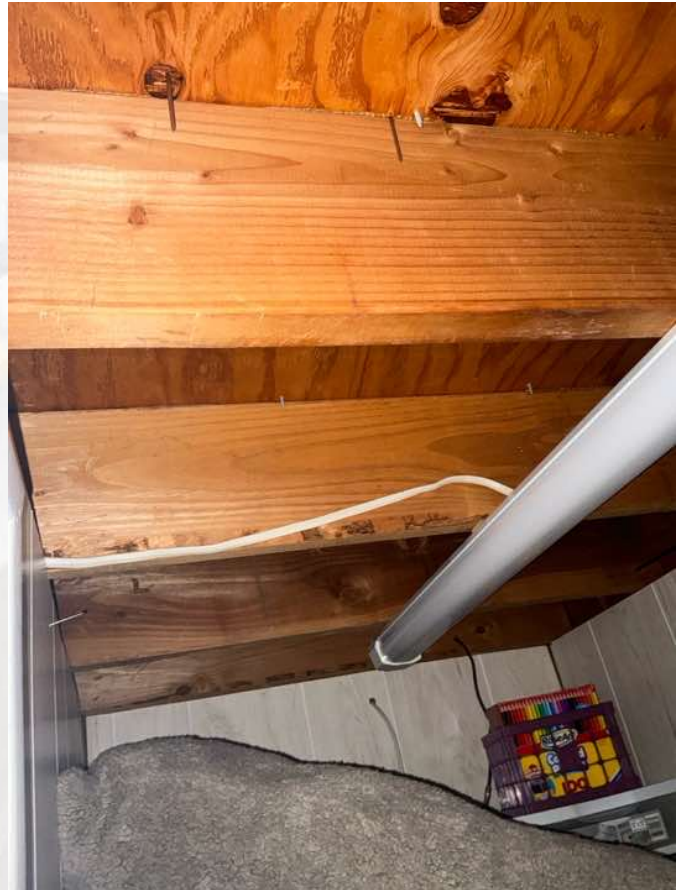
**MED 66:** Exposed electrical wiring was observed beneath the staircase. Exposed wiring is susceptible to physical damage and may present a safety hazard. Recommend evaluation and correction by a qualified licensed electrician.

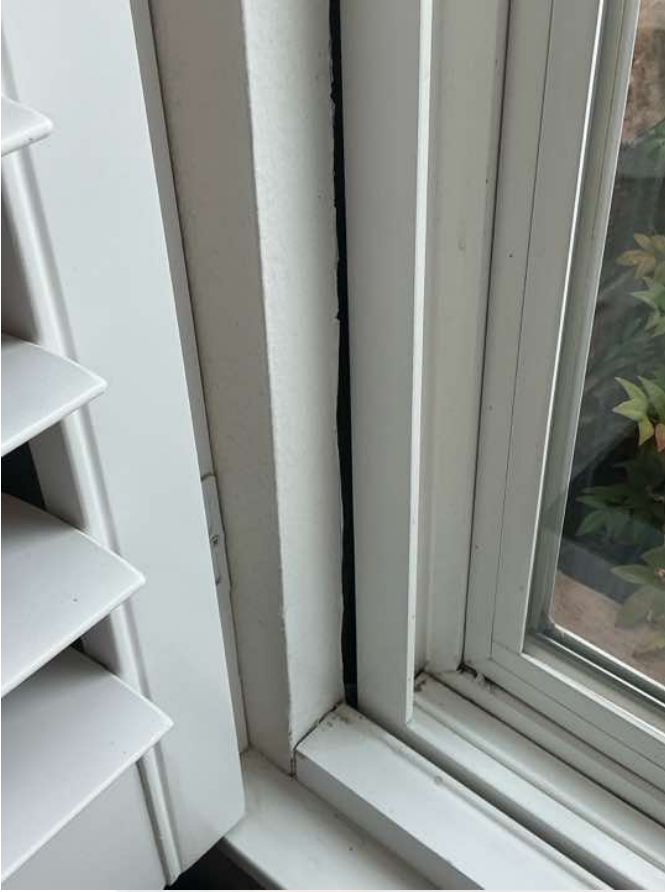
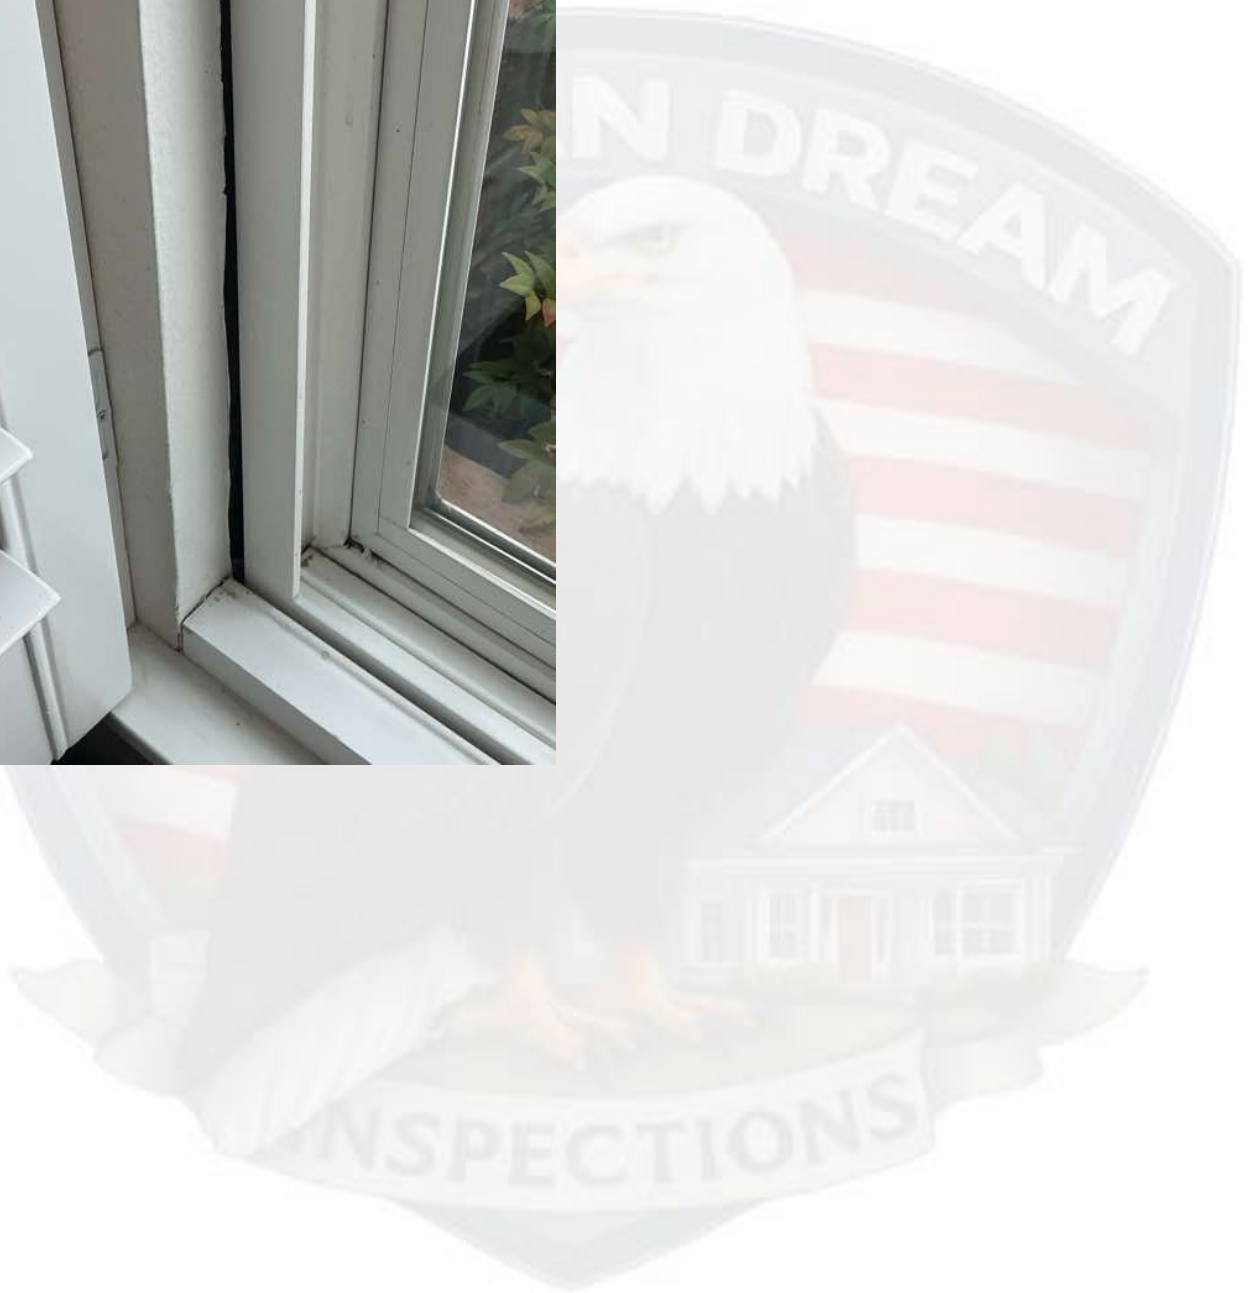
**MIN 67:** The front windows were not sealed in a finished like standard. We recommend caulking or sealing to make a more aesthetically pleasing appearance.

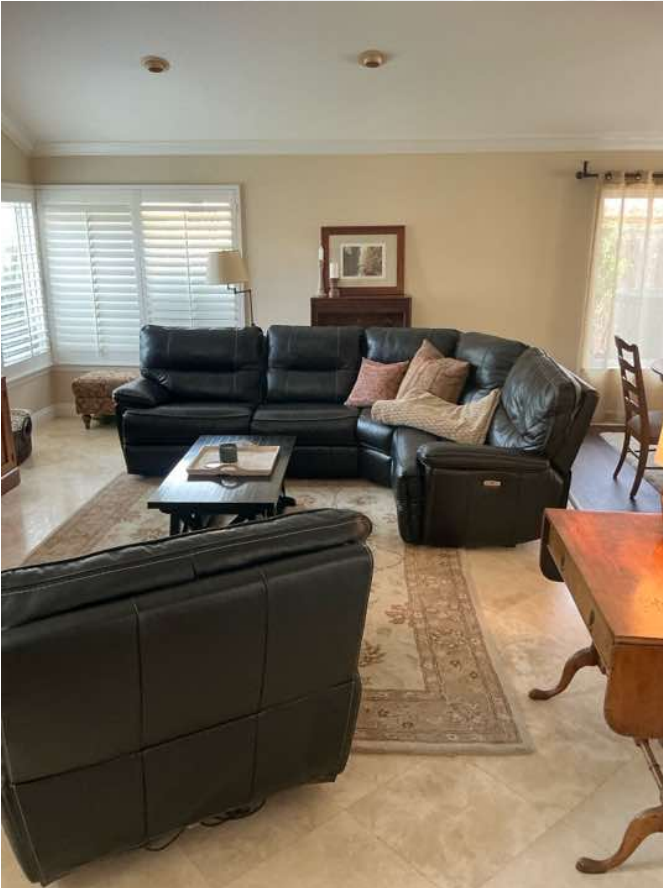
A carbon monoxide (CO) alarm was not observed in the home downstairs. Carbon monoxide is a colorless, odorless gas that can pose a serious health risk, particularly in homes with fuel-burning appliances.

Recommendation: Install approved carbon monoxide alarm(s) in accordance with current safety standards, typically outside of sleeping areas and on each level of the home as required.

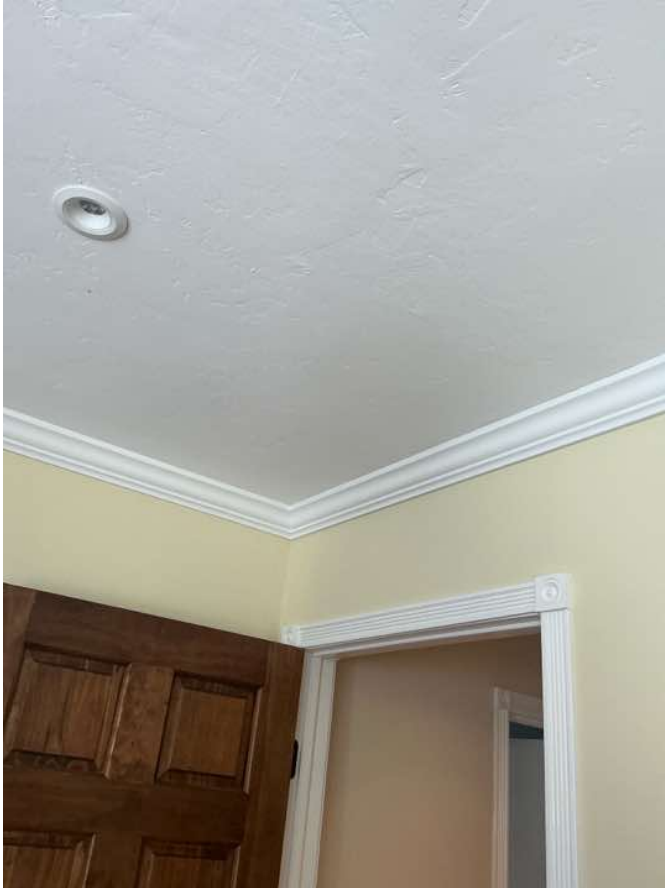
**MJR 69:** There is no smoke detector in this area, as required. We recommend one be installed.

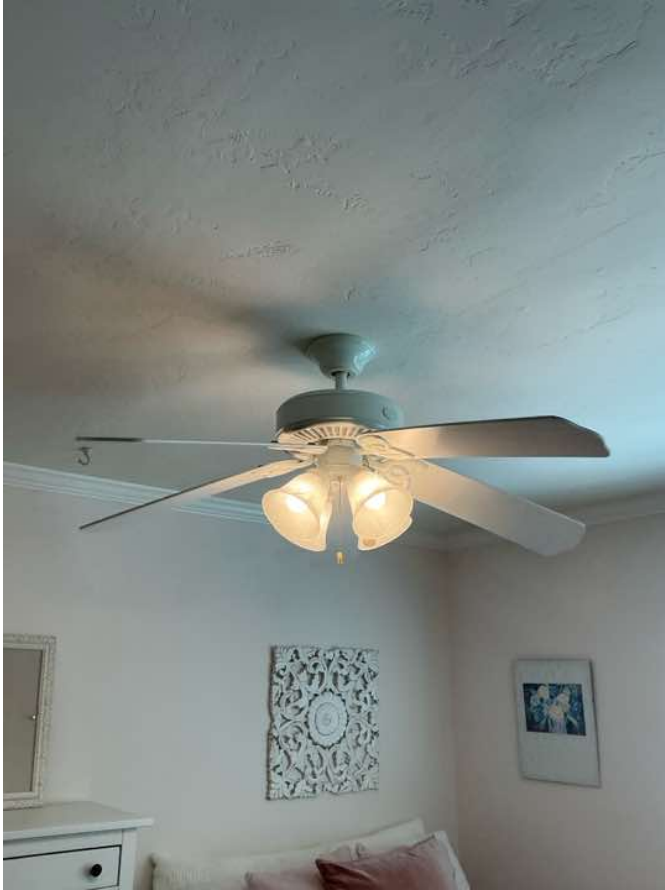
**MED 70:** The ceiling fan light fixture is making unusual noises when operated. We recommend it be repaired or replaced.

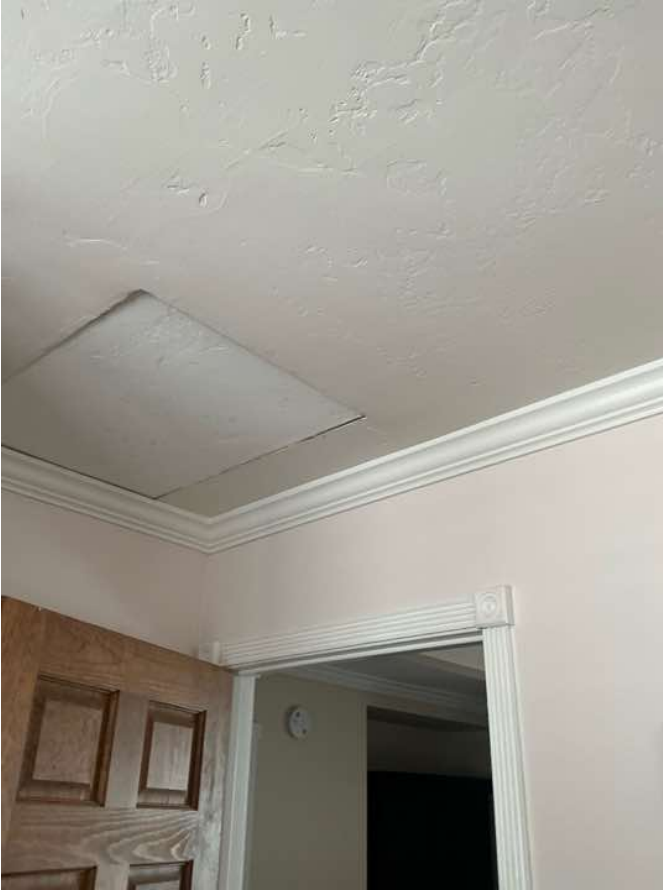
**MJR 71:** There is no smoke detector in this area, as required. We recommend one be installed.

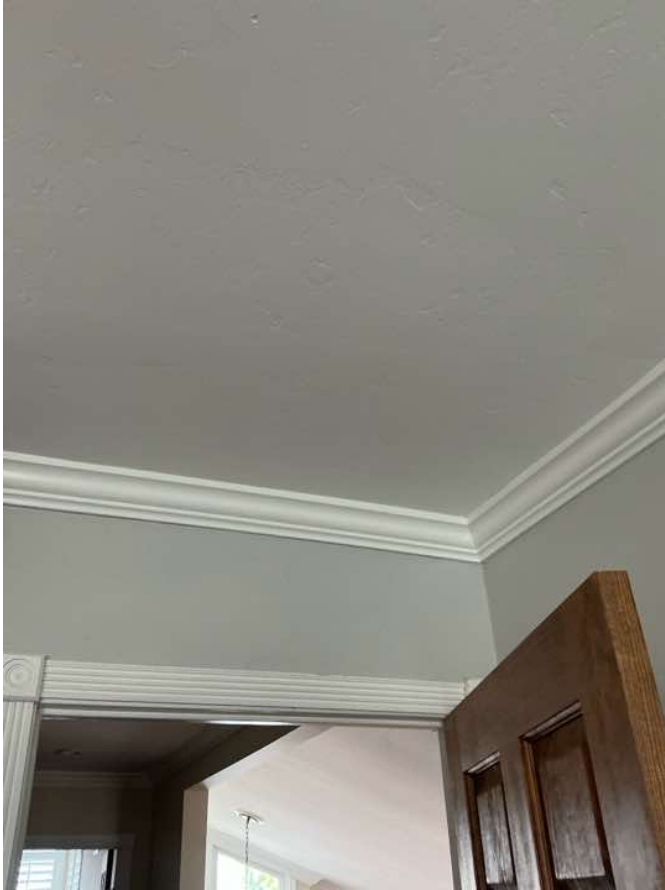
**MJR 72:** There is no smoke detector in this area, as required. We recommend one be installed.
