# Inspection Report

Derek A. Porter NACHI25090320  
American Dream Property Inspection Service  
(619) 517-3029  
propertyevaluations@gmail.com  
Serving All Of Southern California

Sample Property

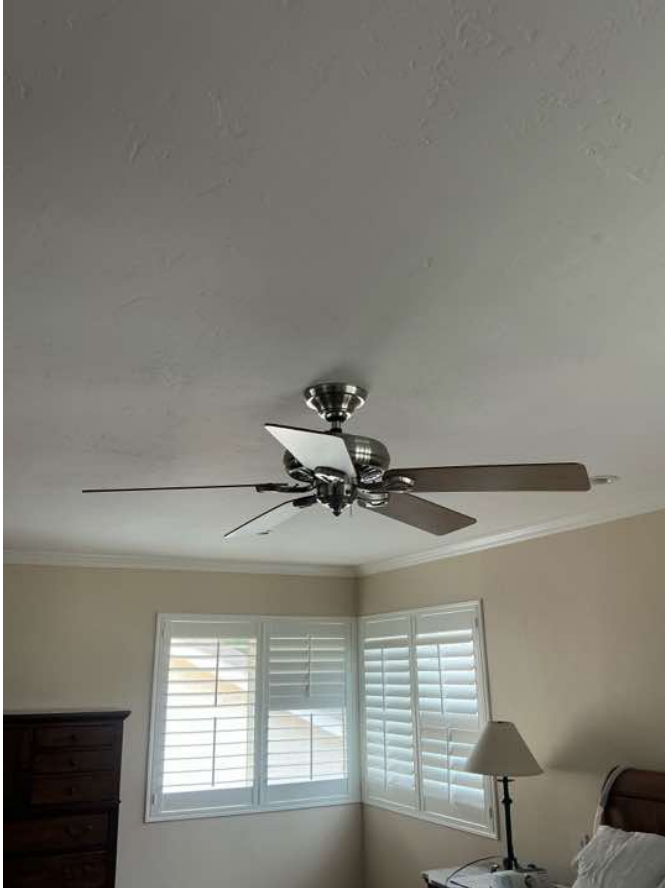
**MIN 73:** No wall switch or remote control was found to operate the ceiling fan. The fan could not be tested due to the lack of an accessible means of operation. Recommend locating the remote or providing an appropriate means of operation and verifying proper function.

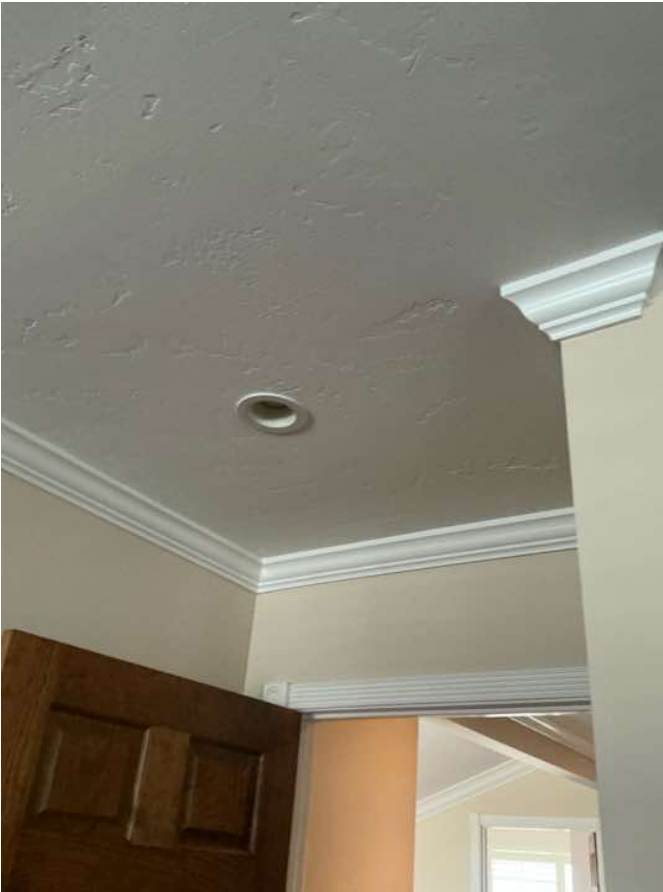
**MJR 74:** There is no smoke detector in this area, as required. We recommend one be installed.

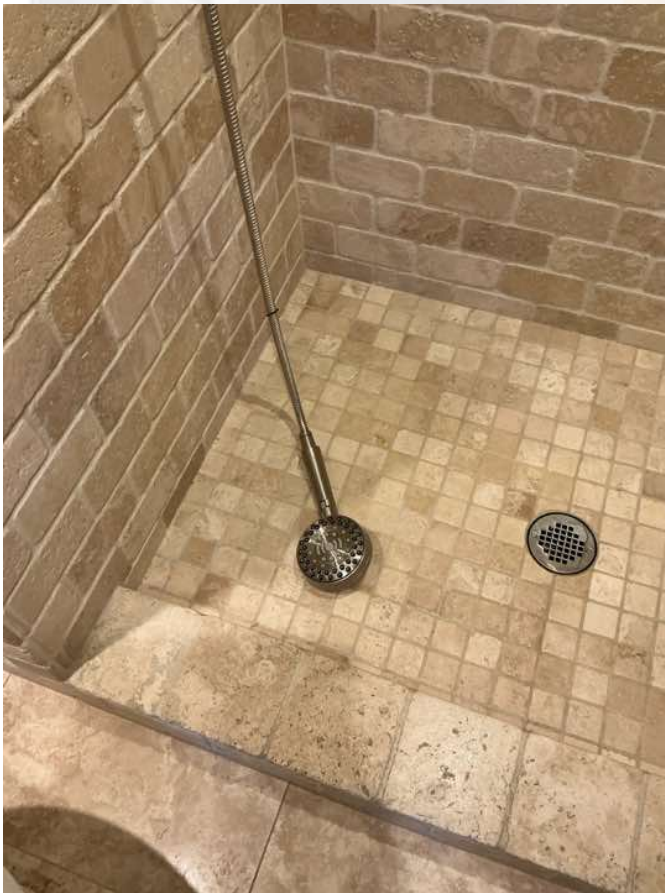
**MED 75:** Shower wand hose length allows the spray head to rest in the shower pan. The handheld shower wand hose is excessively long, permitting the spray head to lay inside the shower pan. This condition can create a cross-connection/backflow risk if the head becomes submerged, potentially allowing contaminated water to siphon back into the potable water supply. We recommend shortening the hose length or installing an appropriate backflow prevention device, and verifying safe configuration by a qualified plumbing contractor.

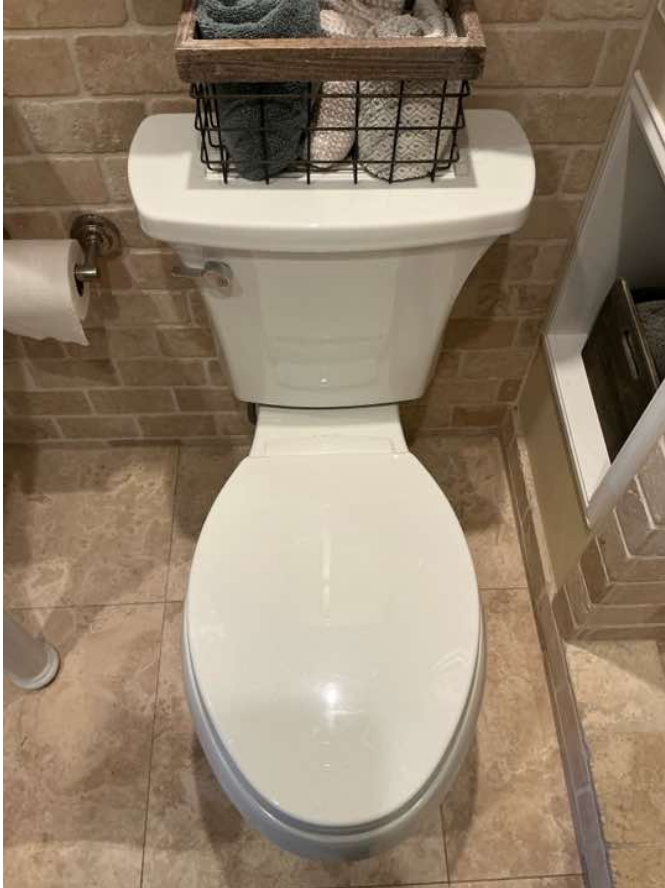
**MED 76:** The toilet is loose at the floor. While no damage was evident, this condition should be taken care of so that leakage does not develop and cause damage. We recommend that the toilet be removed and rebolted with a new wax seal.

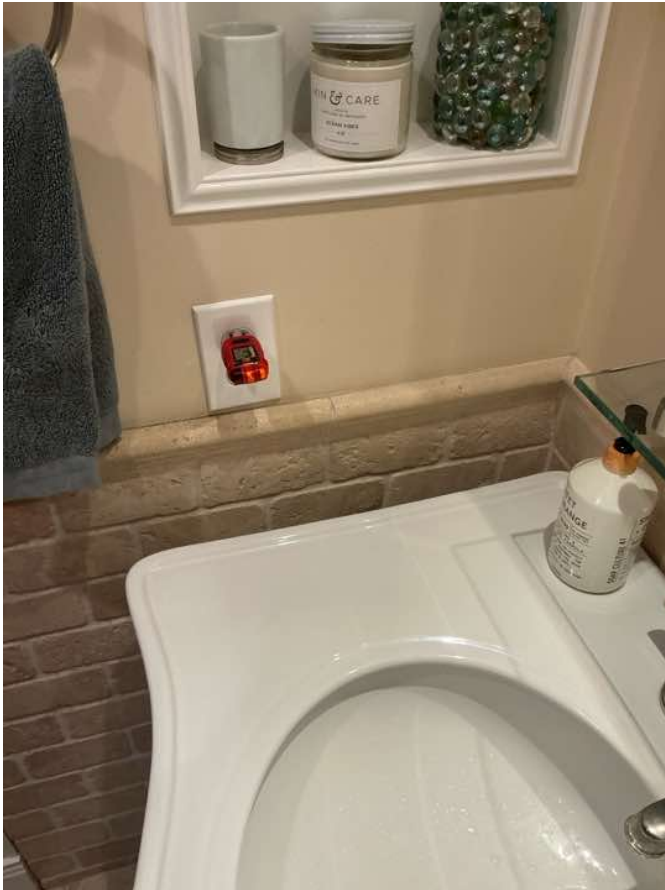
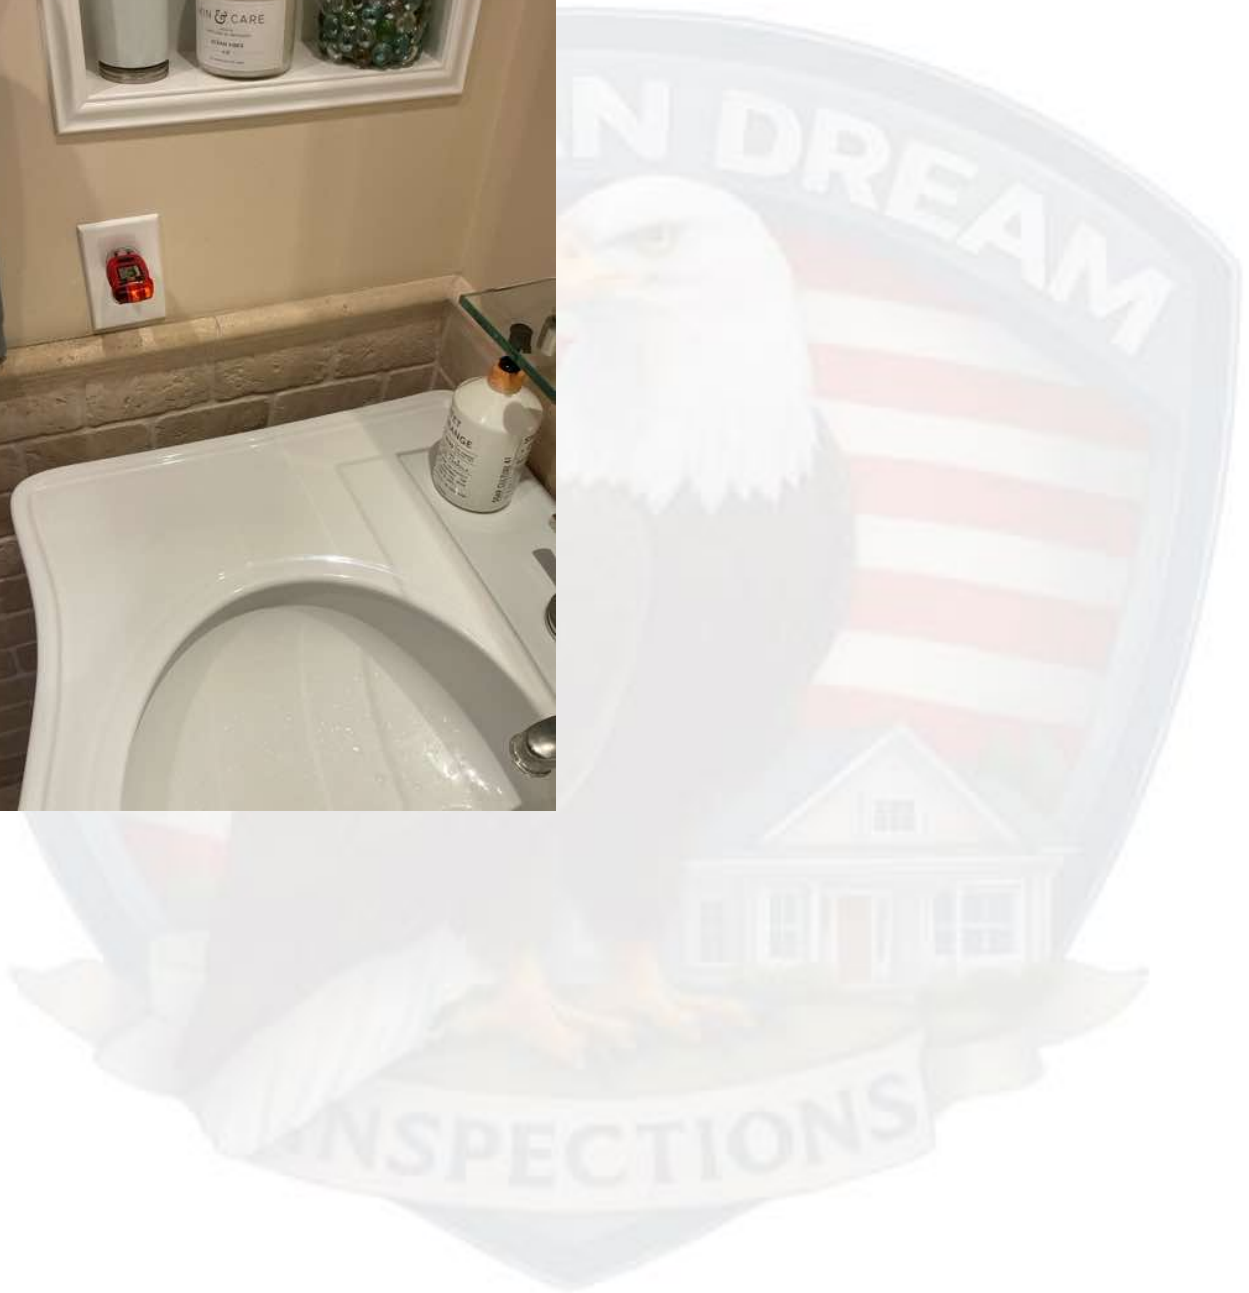
**MJR 77:** There is no GFCI (ground fault circuit interrupter) protection for this bathroom. For an increased margin of safety, we recommend the installation of a GFCI receptacle.

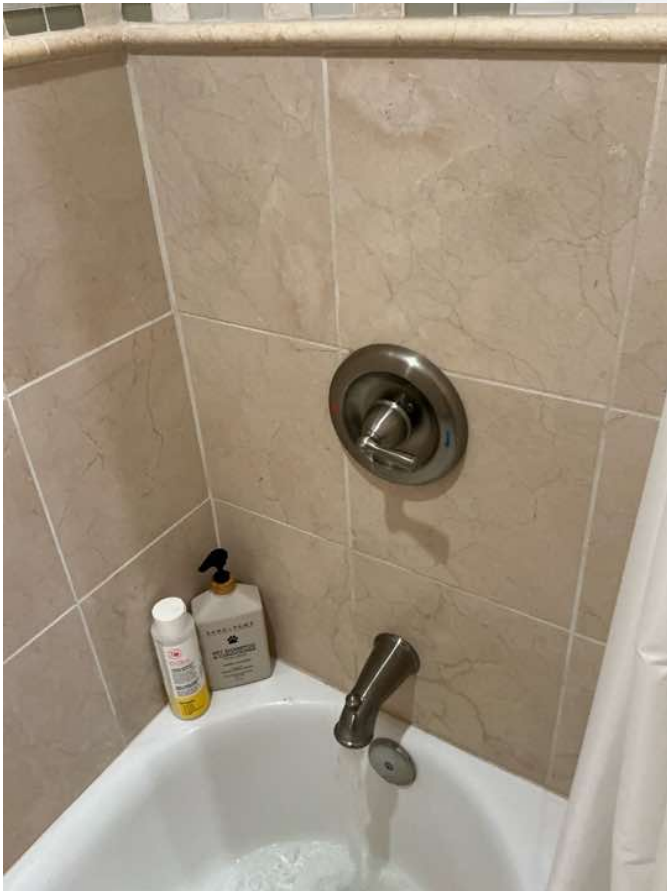
**MED 78:** The tub faucet hot and cold water controls are reversed. Reversed hot and cold water can result in hot water burns. We recommend that this condition be corrected.

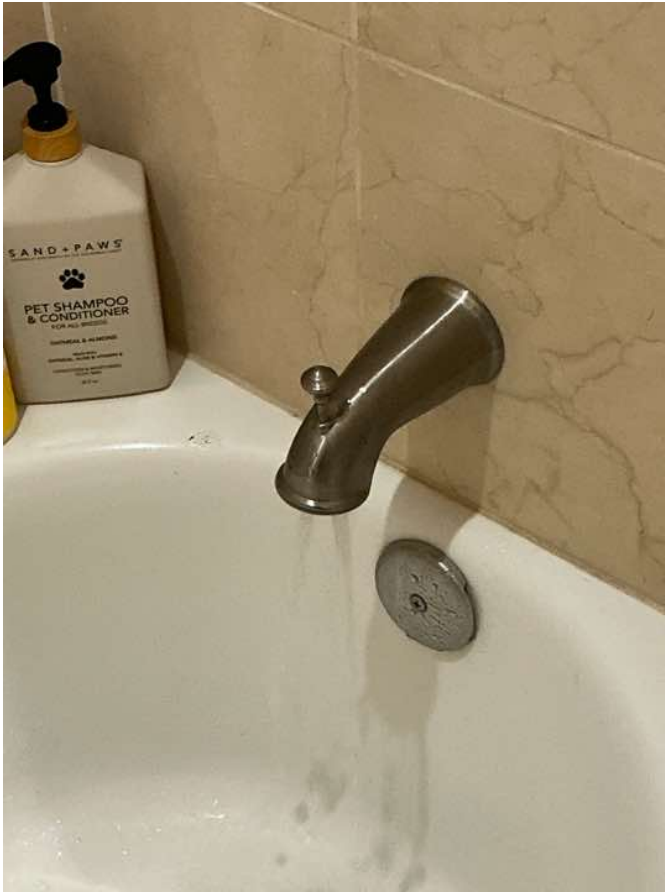
**MIN 79:** The shower/tub diverter is leaking when the shower is operated. We recommend repair.

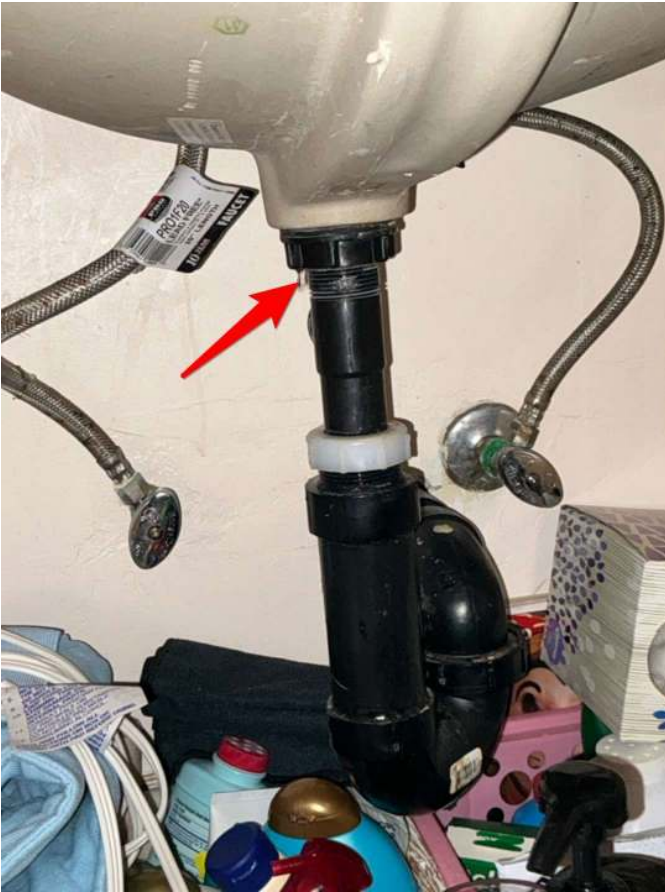
**MJR MED 80:** The drain pipe fitting is leaking. We recommend it be repaired or replaced.

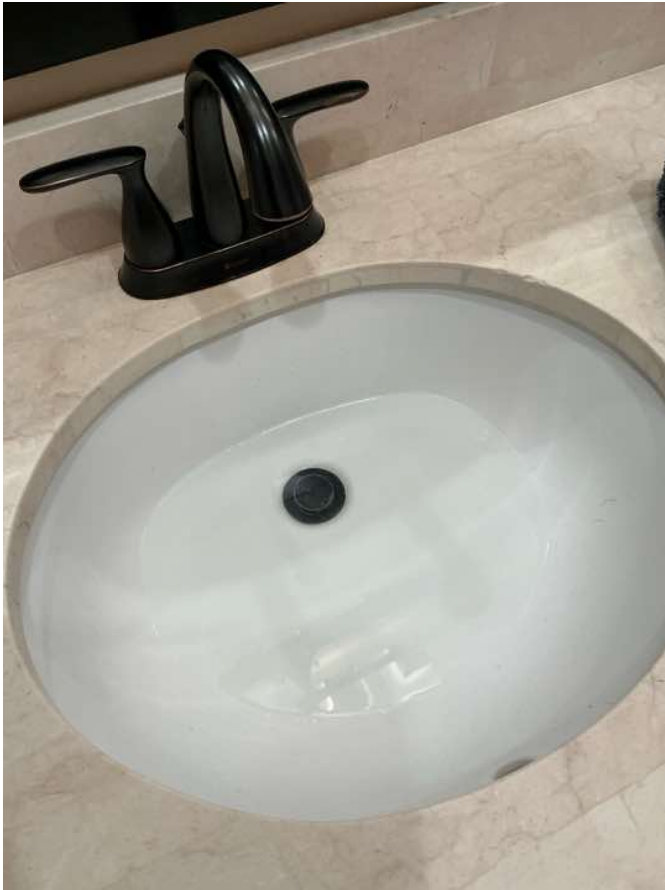
**MED 81:** The drain is slow. We recommend the trap be cleaned of hair, sludge, etc. and if this does not correct the problem, we recommend the line be 'snaked' by a professional sewer cleaning service.

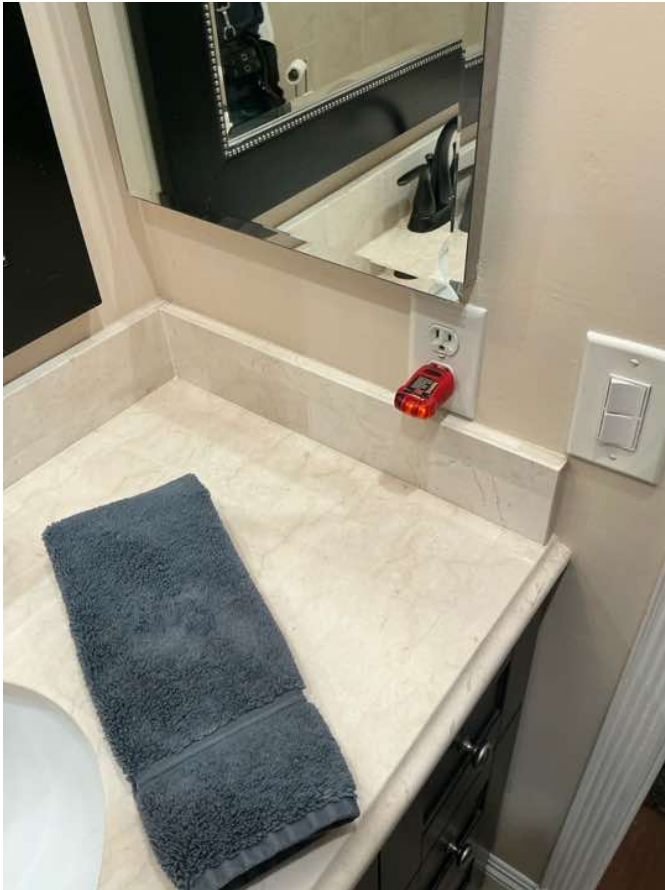
**MJR 82:** There is no GFCI (ground fault circuit interrupter) protection for this bathroom. For an increased margin of safety, we recommend the installation of a GFCI receptacle.

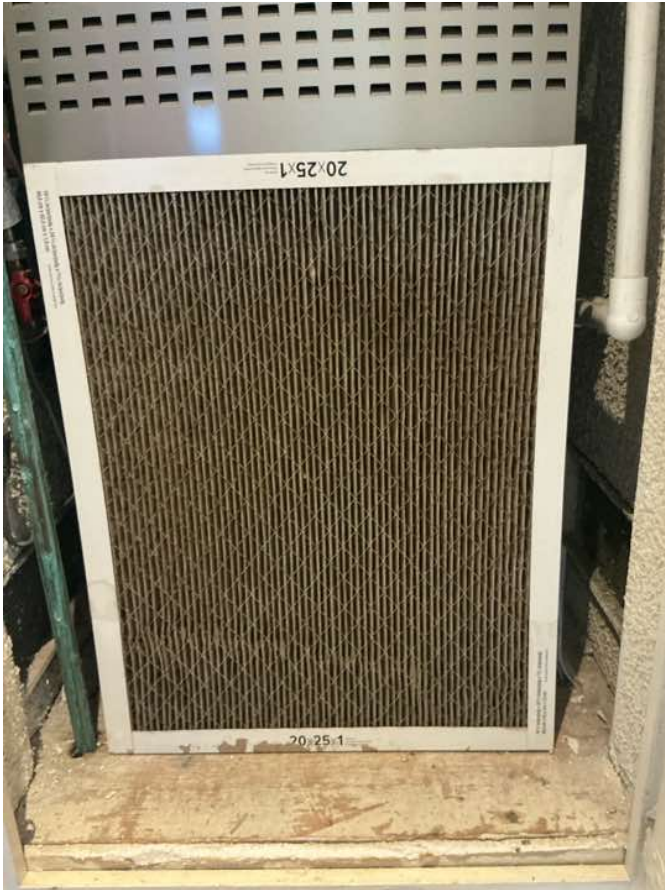
**MIN 94:** The filter has accumulated debris which decreases its effectiveness and blocks air flow. This can dramatically decrease the efficiency of the heating system. We recommend the filter be removed, cleaned and replaced if necessary.

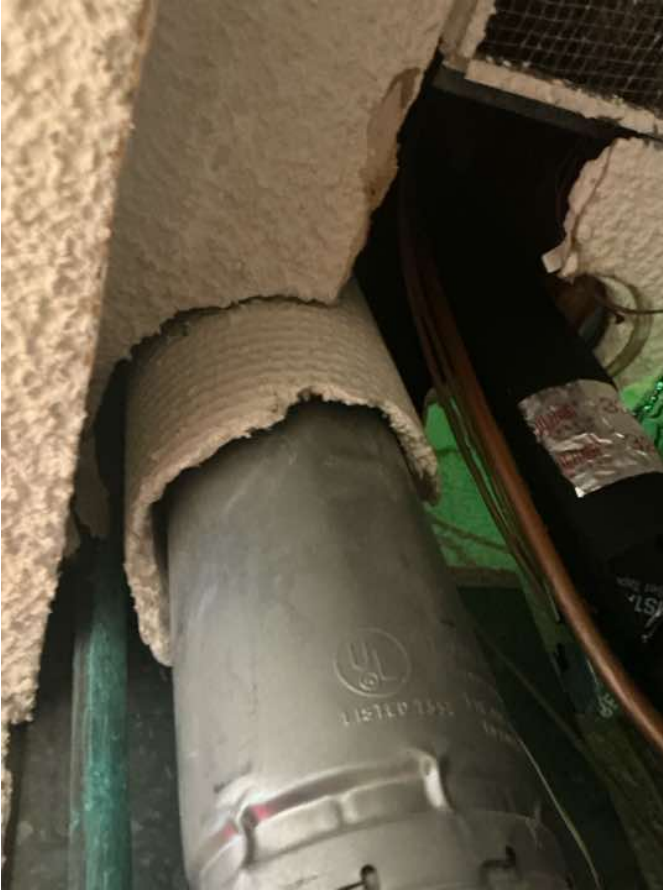
**MED 95:** The vent connector terminates within a transite (asbestos cement) flue pipe which does not meet present standards. No problems were noted, but the local building department may require upgrading at the time the heating system is replaced.

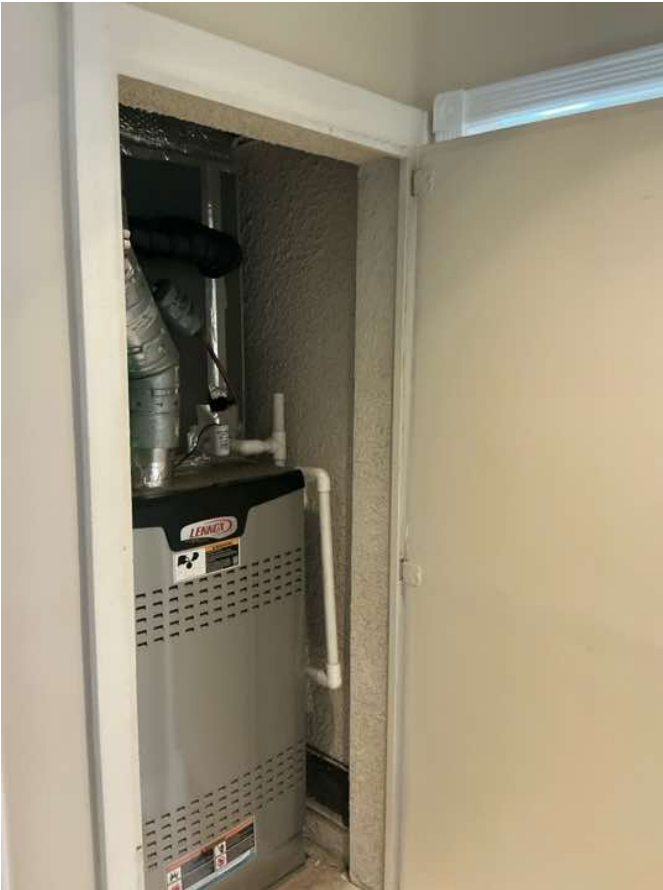
**MED 98:** When the furnace is in operation the closet door should be kept closed to prevent the return air inlet from drawing combustion air out of the closet and spreading products of combustion into the house.

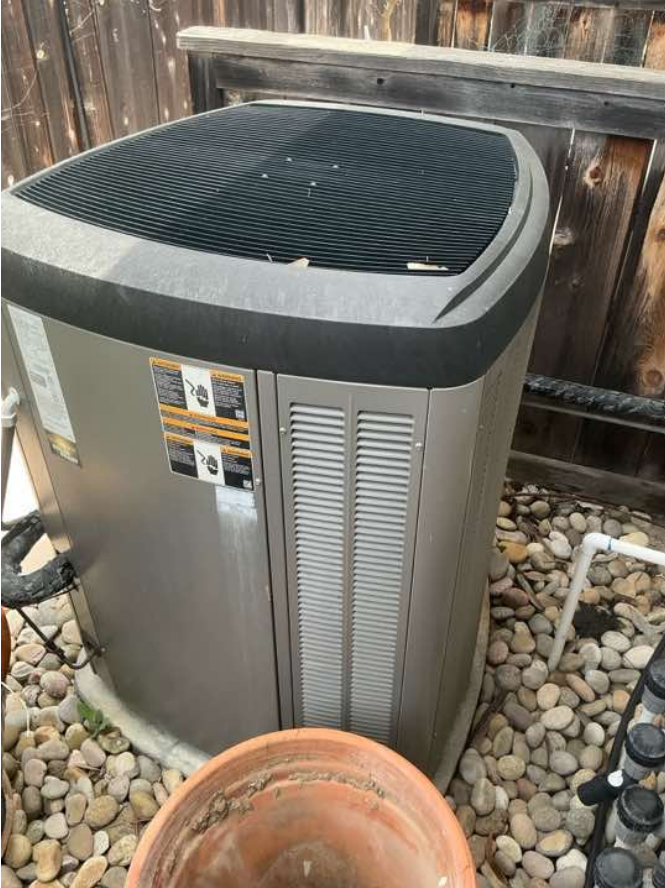
**MIN 116:** The condensing unit is not secured (strapped) as is the current standard.

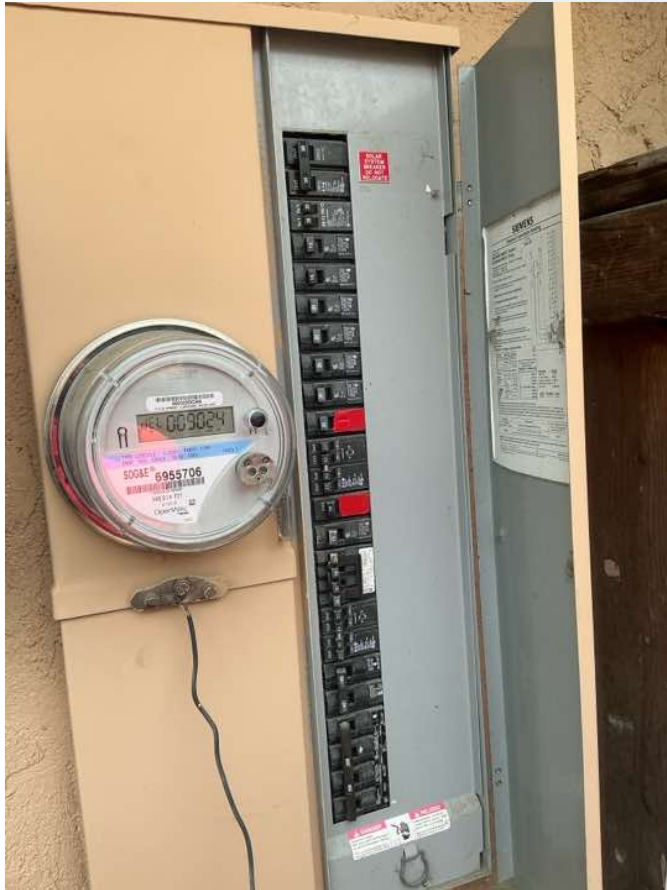
**MIN 131:** The circuitry in the panel is unlabeled. We recommend this be corrected to allow individuals unfamiliar with the equipment to operate it properly when and if it becomes necessary.

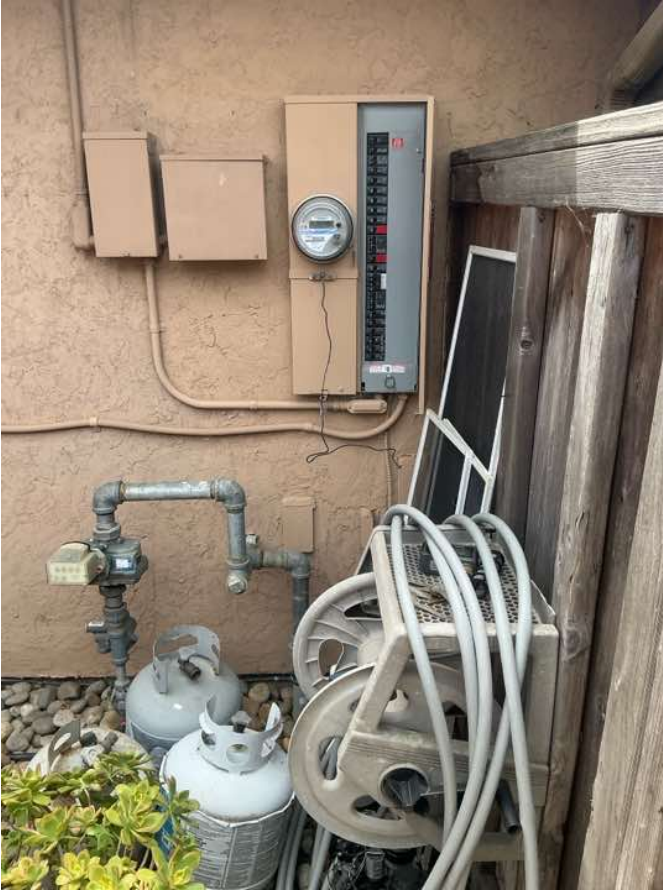
**MED 132:** The required working clearance in front of the electrical panel was inadequate due to permanent obstructions. This condition may impede safe access to the panel. Recommend correction by a qualified licensed electrician or qualified contractor.

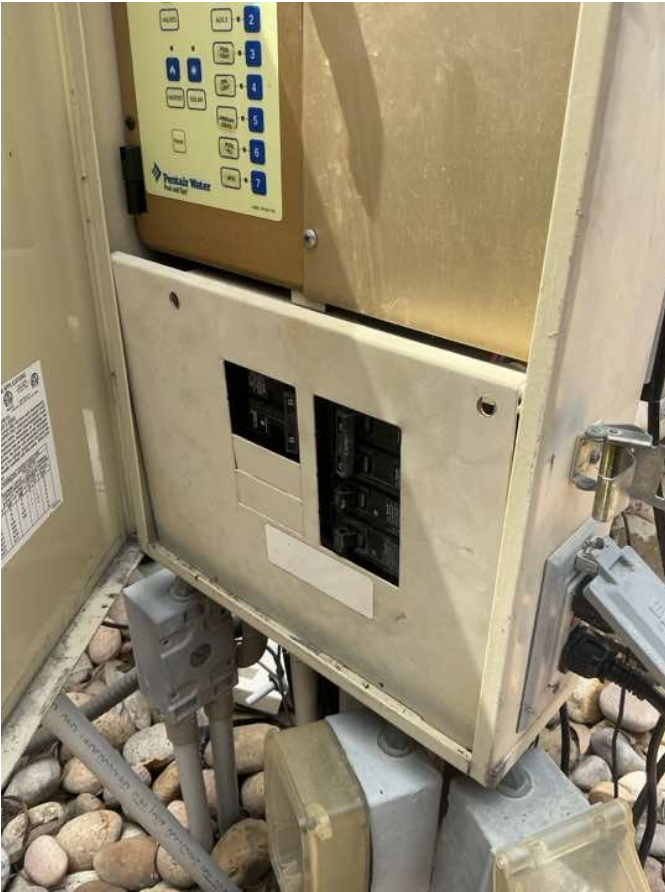
**MED 135:** Some of the subpanel cover screws are missing. We recommend installation of proper blunt-end screws.

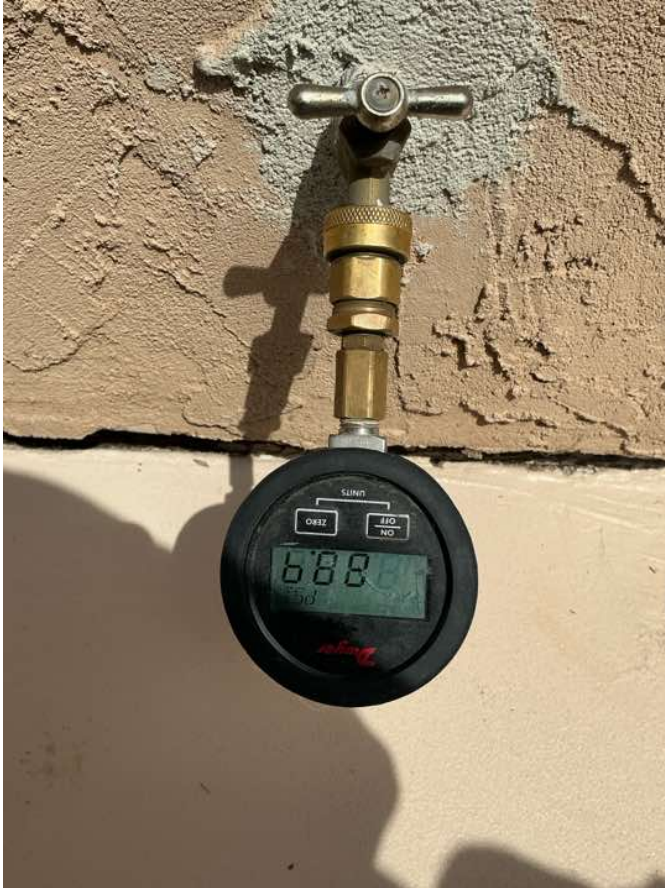
**MED 144:** The system water pressure, as measured at the exterior hose bibs, is excessive. This can result in unnecessary leakage and damage of system valves, seats and washers. We recommend that a pressure reduction valve be installed.

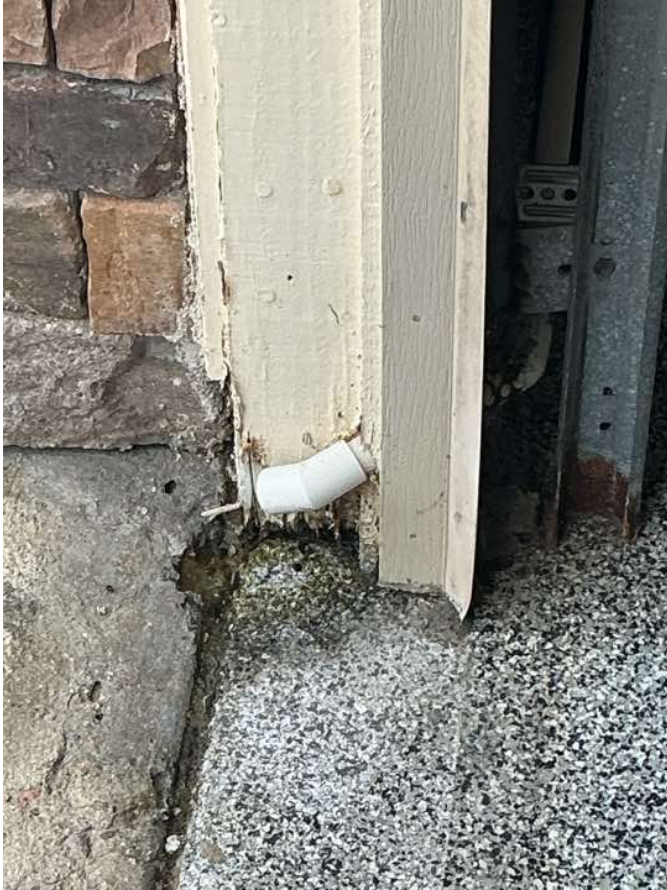
**MED 145:** The drain piping for the water softener has been installed in a substandard manner by terminating at the vehicle door. This is causing moisture damage to the door frame. We recommend it be repaired or replaced.

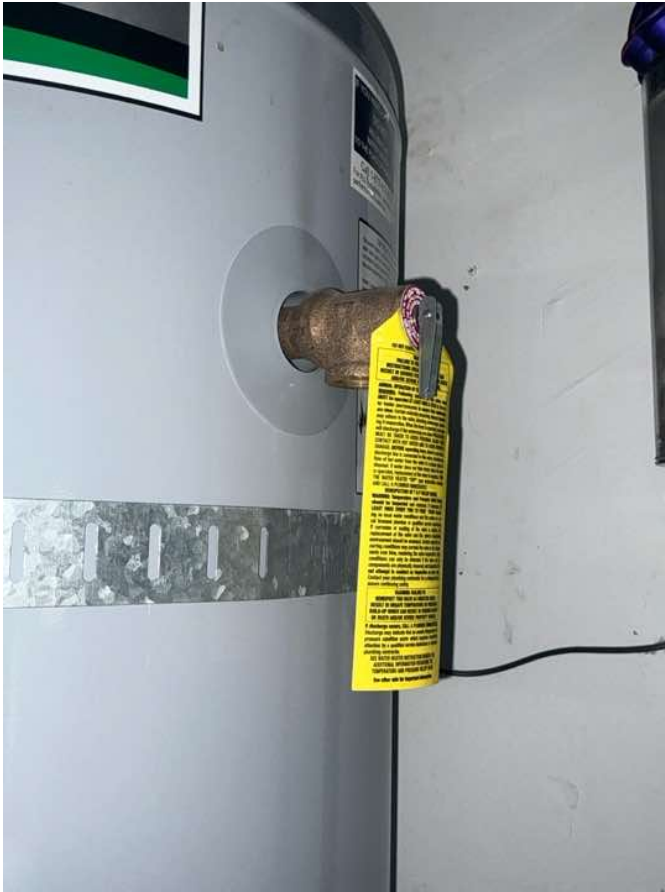
**MED 155:** The temperature and pressure relief valve lacks a discharge pipe. We recommend the installation of approved piping to an approved location.

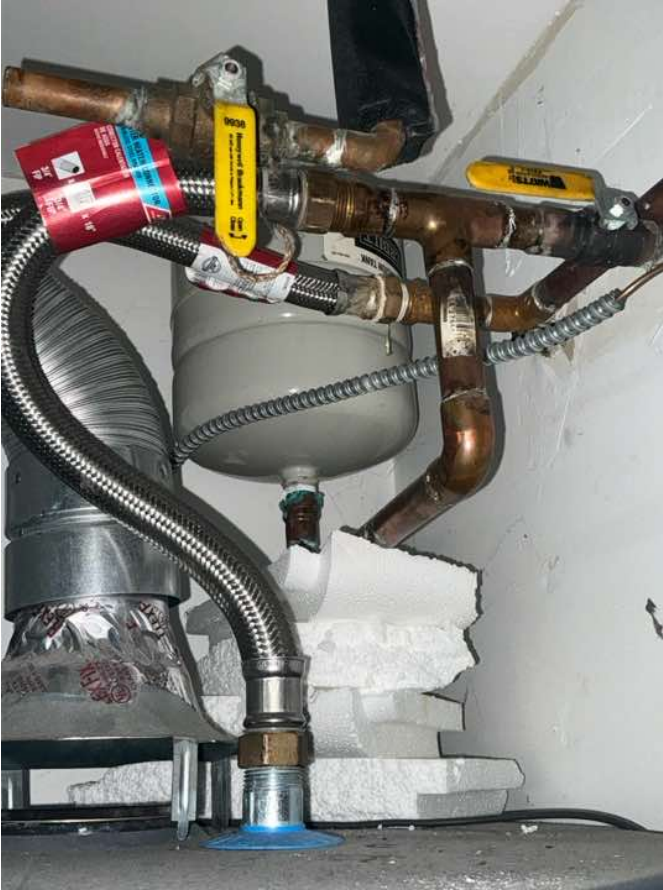
**MED 156:** The thermal expansion tank at the water heater is not properly secured with an approved strap or support. Expansion tanks filled with water can become heavy and place stress on the connected plumbing piping if left unsupported. Recommend installation of proper strapping or support by a qualified contractor to help prevent movement, pipe damage, or leaks.

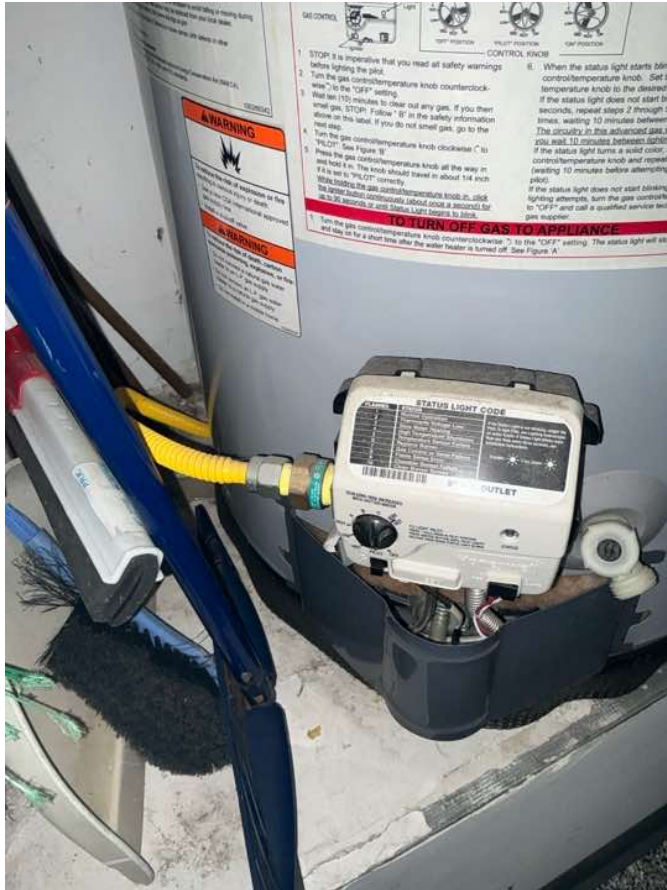
**MIN 157:** The fuel piping does not include a 'T' extension to collect condensation and debris, as is considered good practice. In the course of future upgrading or repair, a 'drip leg' should be added to the gas piping just ahead of the connector.

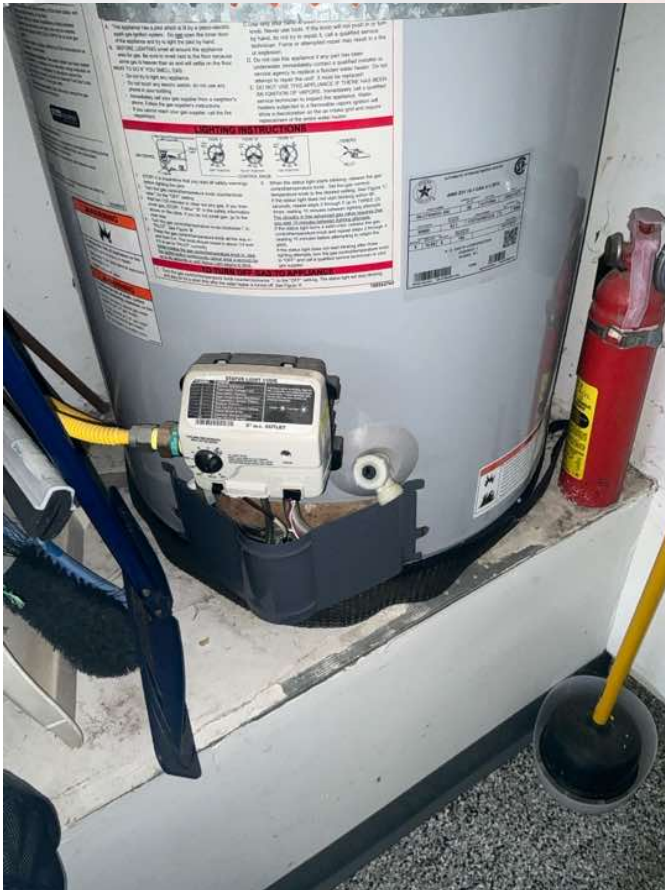
**MED MIN 164:** There is no metal pan under the water heater to catch and divert any dripping water to the exterior. This is required by some jurisdictions for water heaters in this location. We suggest installation of such a pan be considered.

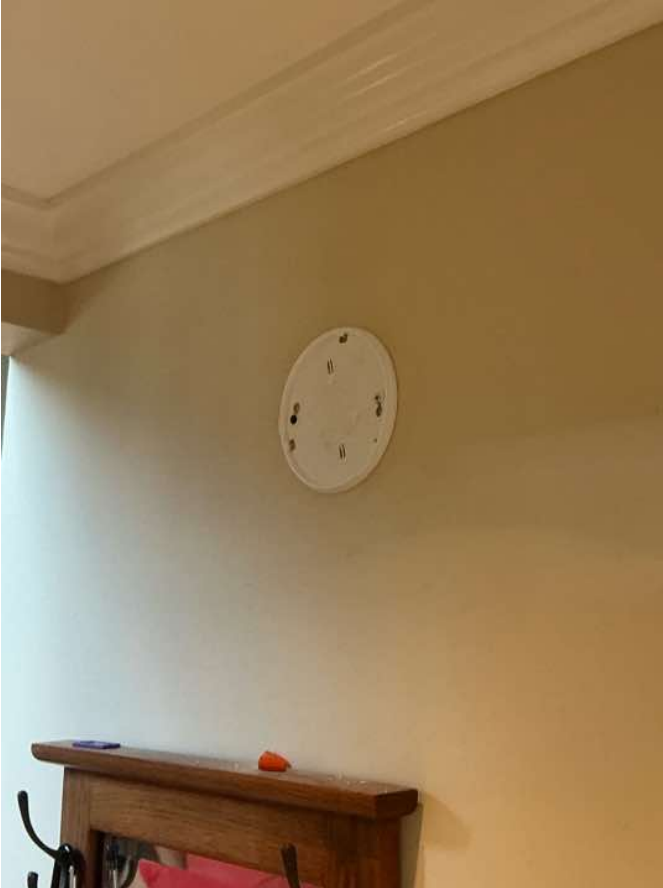
**MJR 166:** There is no smoke detector in this area, as required. We recommend one be installed.

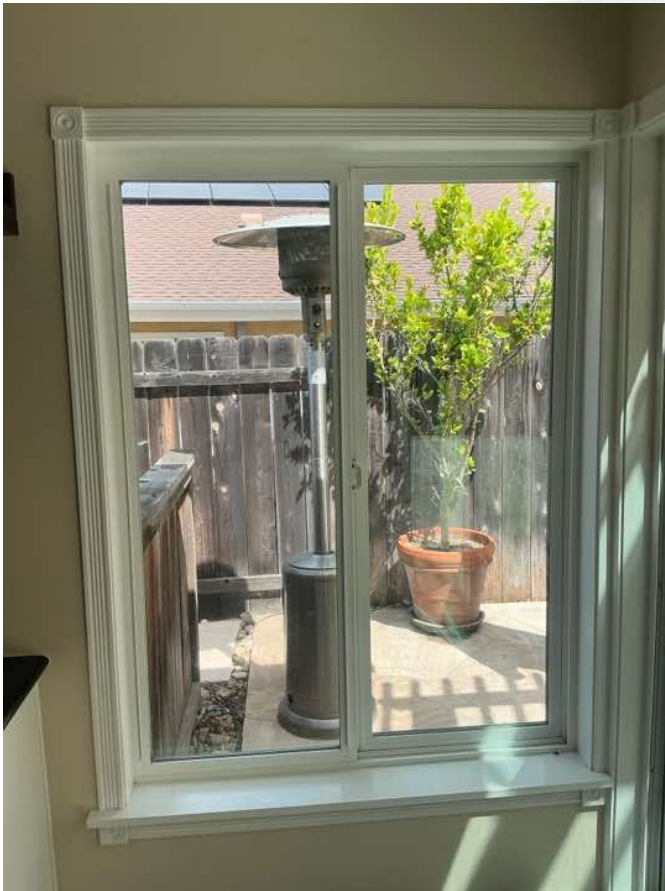
**MIN 167:** One window screen is missing. We recommend it be replaced.

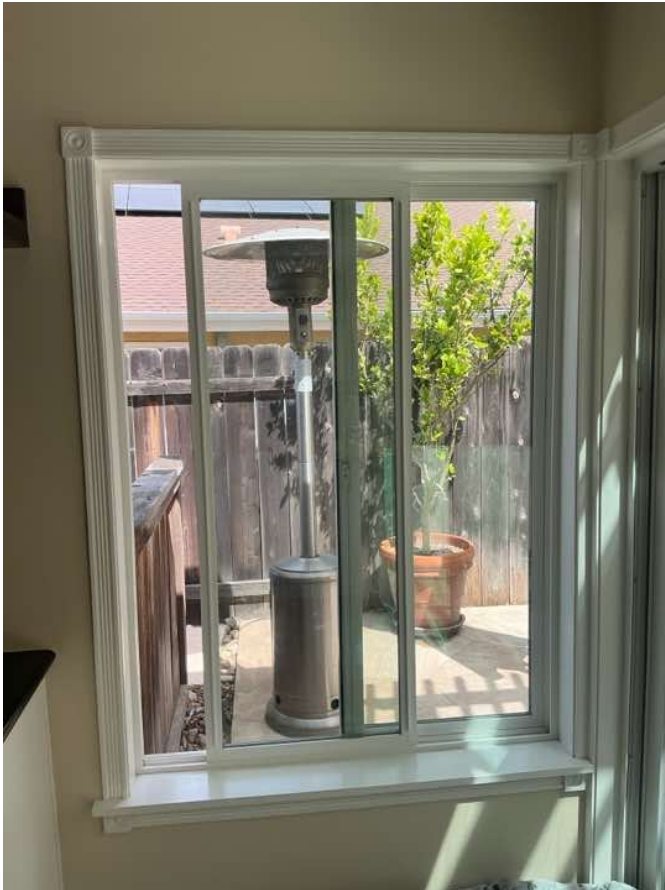
**MIN 168:** There is condensation between the panes of glass of one double pane window. This indicates a failed seal. We recommend the lens assembly be replaced, which is the only method for correcting this deficiency.

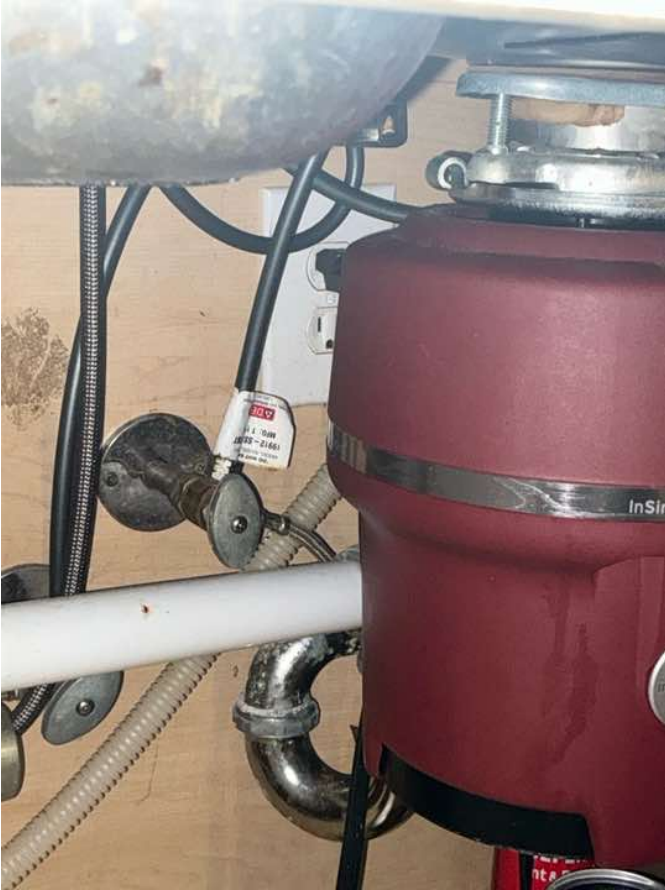
**MJR 169:** A GFCI-protected receptacle is required for the garbage disposal. The disposal was not observed to be GFCI protected at the time of inspection. Correction by a qualified electrician is recommended.

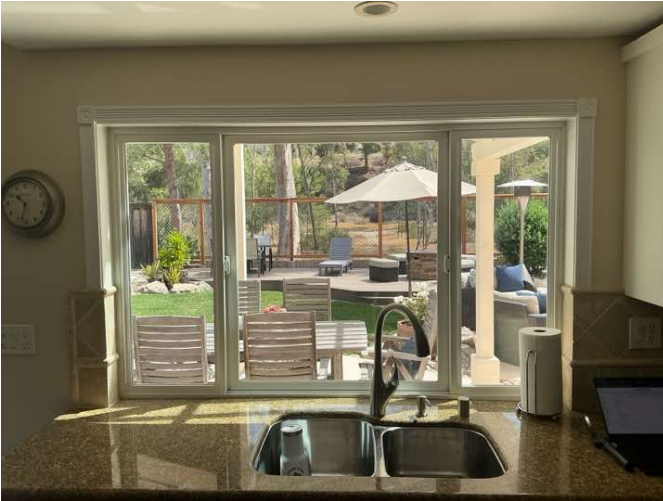
**MIN 170:** Window screens are missing. We recommend they be replaced.

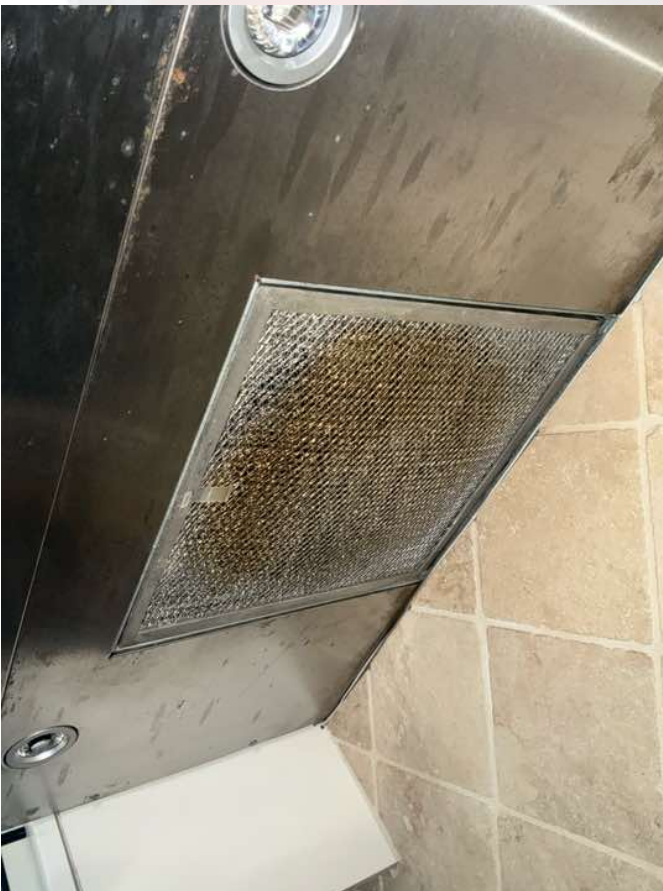
**MED 171:** The filter in the kitchen exhaust is heavily grease-laden. This can become a fire hazard. We recommend this be corrected by thoroughly cleaning the filter, usually most easily accomplished in the dishwasher.

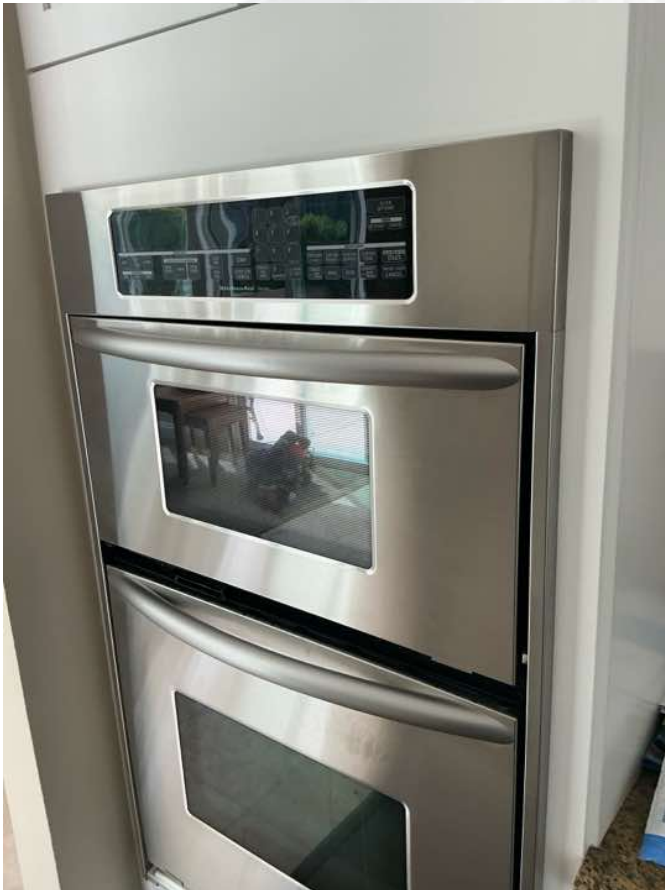
### **MED** 172: Microwave Oven Loose Door

The microwave oven door was observed to be loose. Damage to the door may compromise the proper sealing of the appliance and could affect safe operation.

Recommend repair or replacement of the microwave oven by a qualified appliance professional.

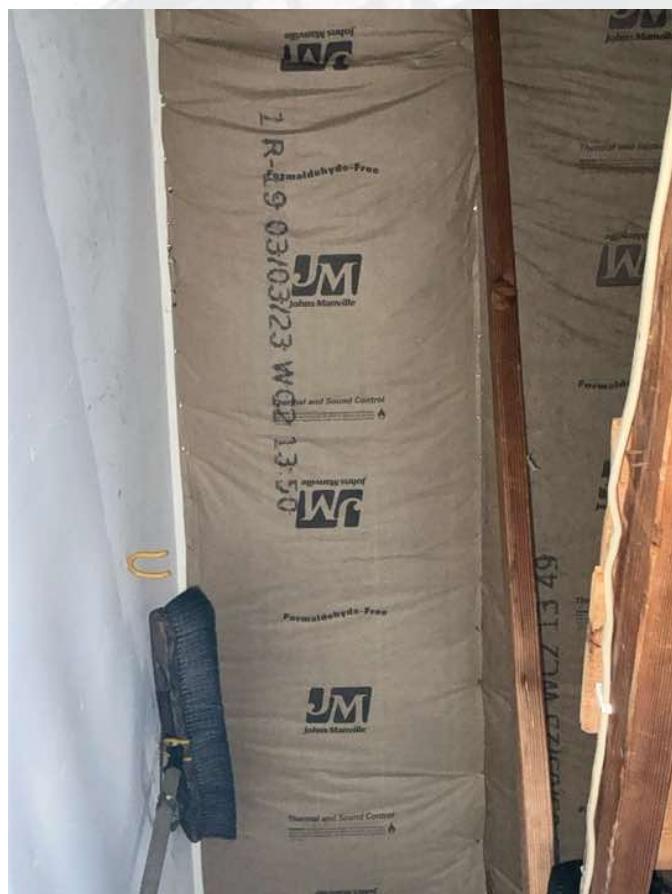
**MED 175:** The garage ceiling insulation appears to be installed with the vapor retarder facing the garage rather than the conditioned living space above. Improper installation can reduce the effectiveness of the vapor retarder and may contribute to moisture-related issues. Recommend correction by a qualified contractor.

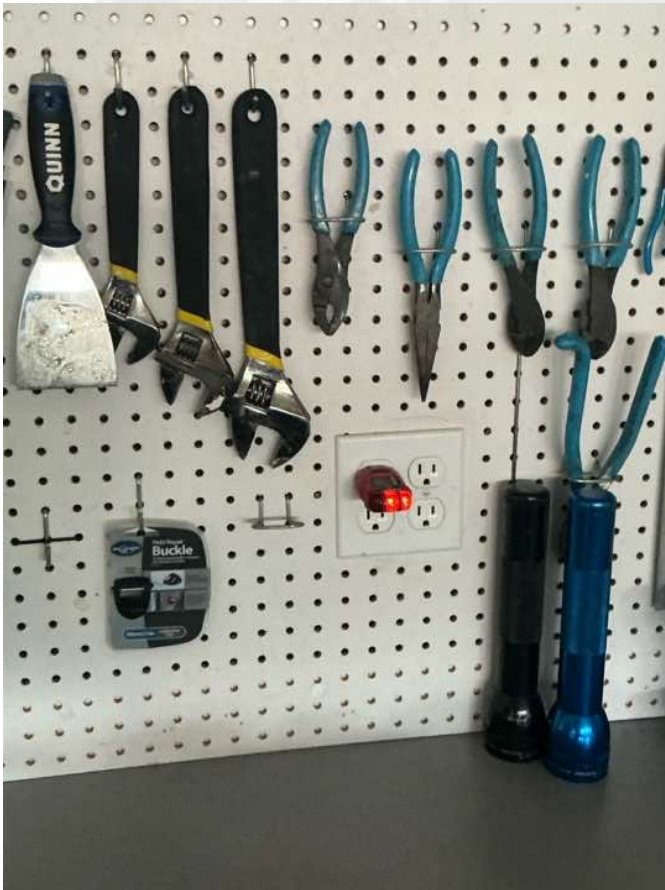
**MJR 176:** No GFCI protection observed for garage receptacles.

The electrical outlets in the garage lack Ground-Fault Circuit-Interrupter (GFCI) protection, which is required by current industry safety standards and the National Electrical Code (NEC) for all 125-volt, 15- and 20-amp receptacles in garages. The absence of GFCI protection increases the risk of electrical shock and electrocution, particularly in areas where concrete floors, tools, vehicles, and possible moisture exposure are present. We recommend installation of proper GFCI protection by a qualified, licensed electrical contractor, followed by verification of correct operation.

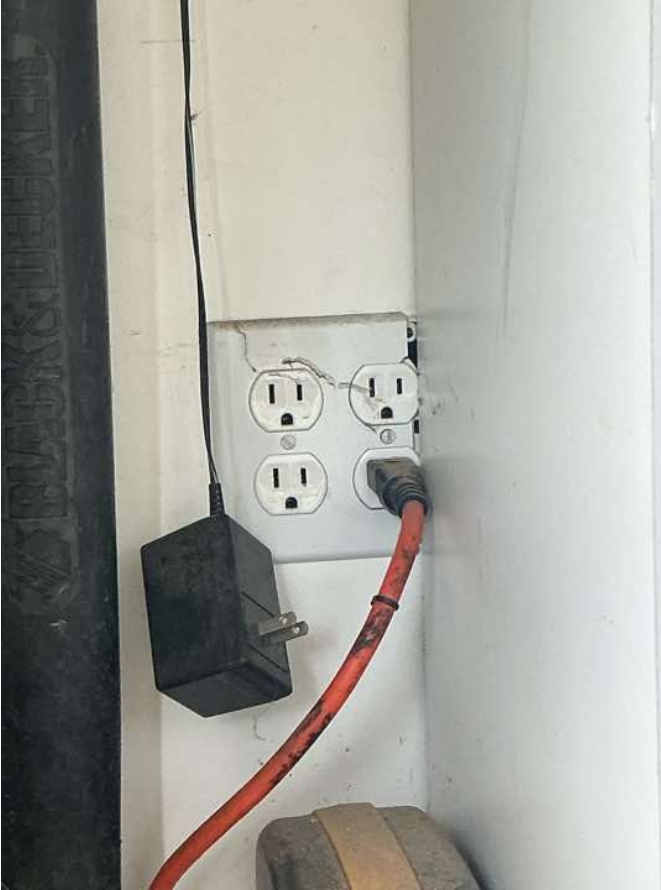
**MED 177:** There is a damaged receptacle cover installed behind the cabinet. We recommend it be replaced during the course of normal maintenance.
