# Inspection Report

Derek A. Porter NACHI25090320  
American Dream Property Inspection Service  
(619) 517-3029  
propertyevaluations@gmail.com  
Serving All Of Southern California

Sample Property

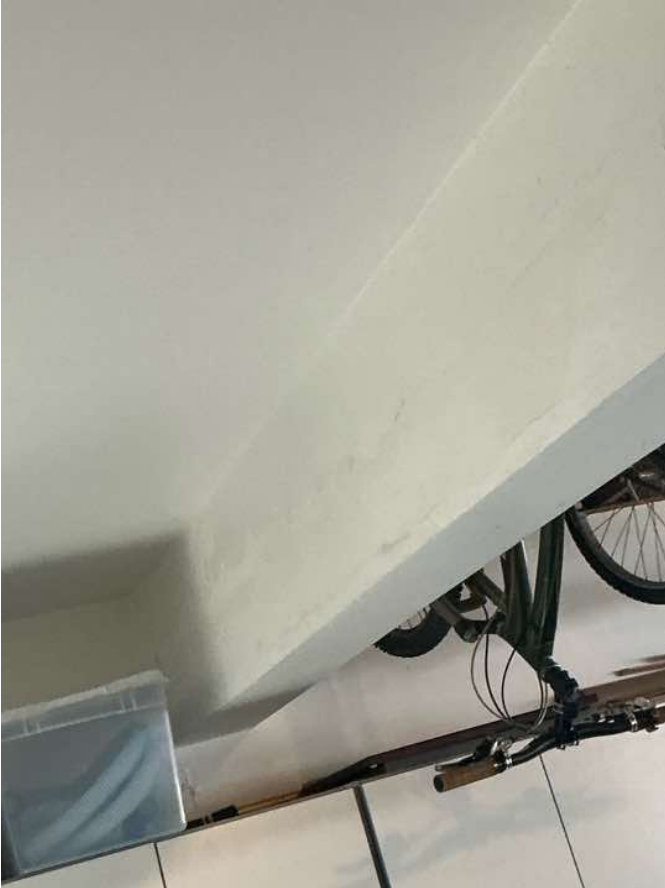
**MED MIN 178:** There are water stains on the ceiling, but no indication that this is an active leak. No action is indicated, but if additional staining develops the source should be identified and necessary repairs performed.

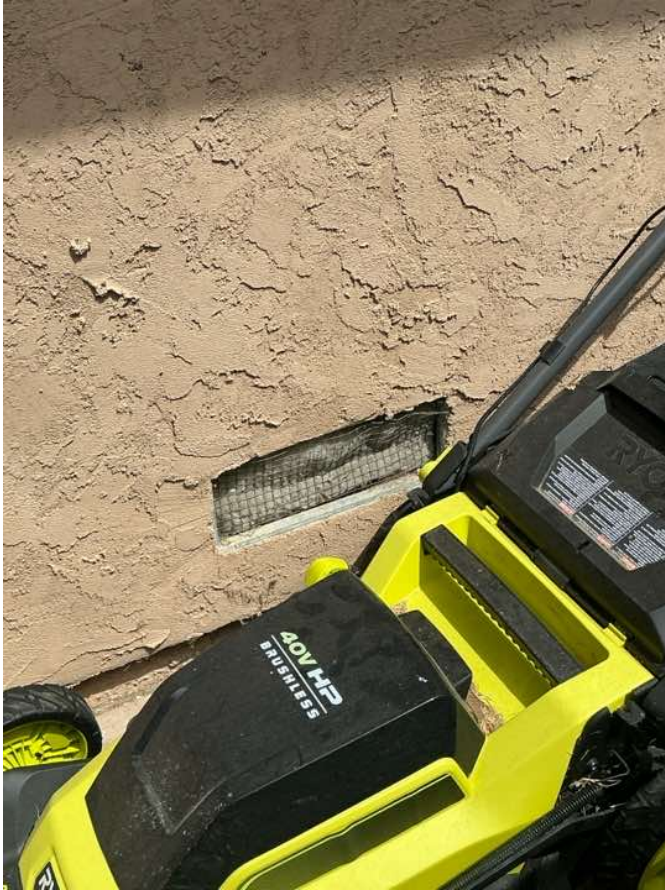
**MED 181:** Garage vents are blocked, restricting circulation and air flow. We recommend they be cleared.

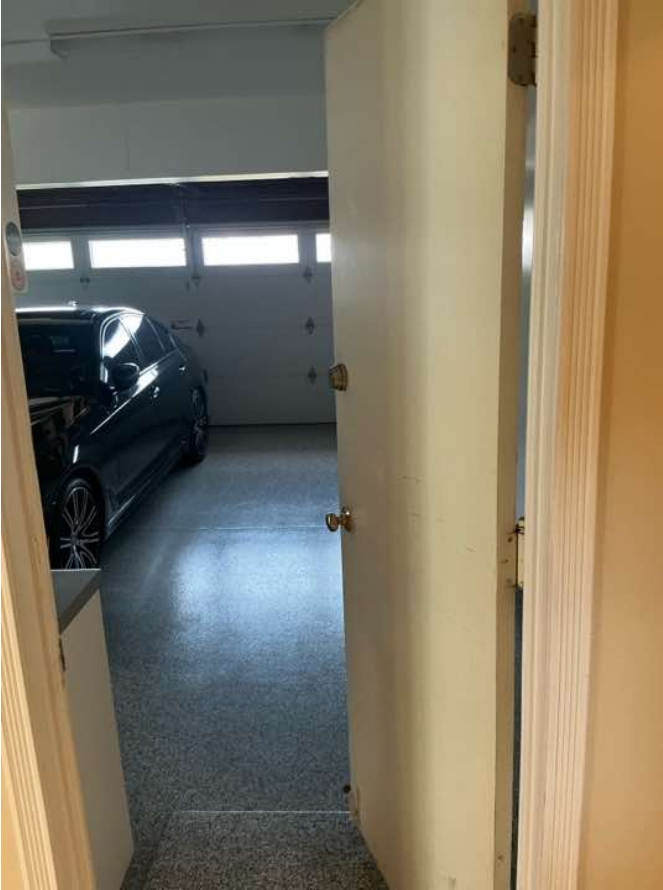
**MED 182:** The door between the garage and the living space is of fire resistive construction, however, the self-closing mechanism has been disabled and the door is no longer a fire-rated assembly. We recommend the self-closing feature be restored.

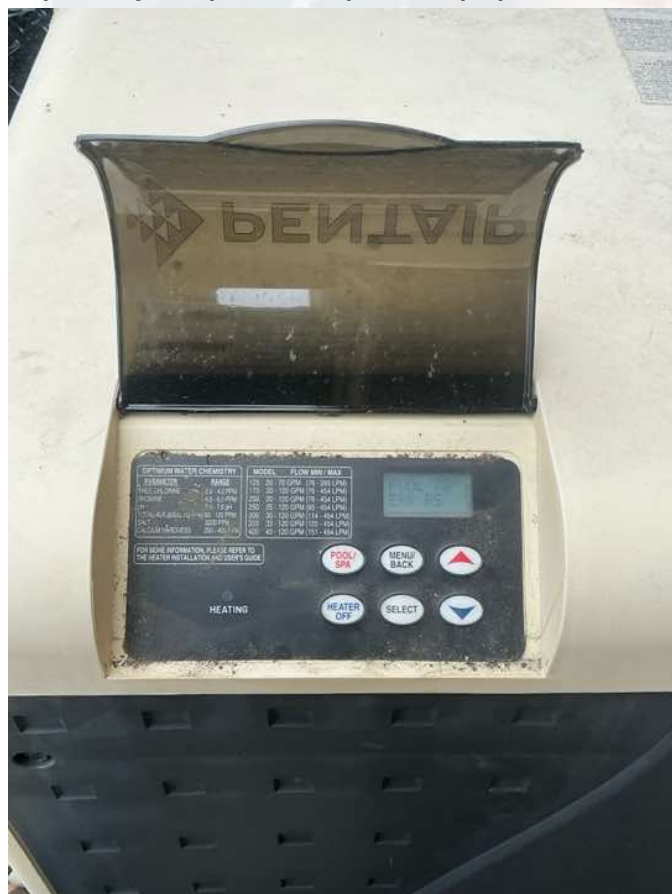
**MED 189:** The pool/spa heater displayed a "PS" error code during testing and did not operate as intended. The code generally indicates that the heater is not detecting adequate water flow or has a pressure switch fault. Recommend evaluation and repair by a qualified pool equipment contractor.

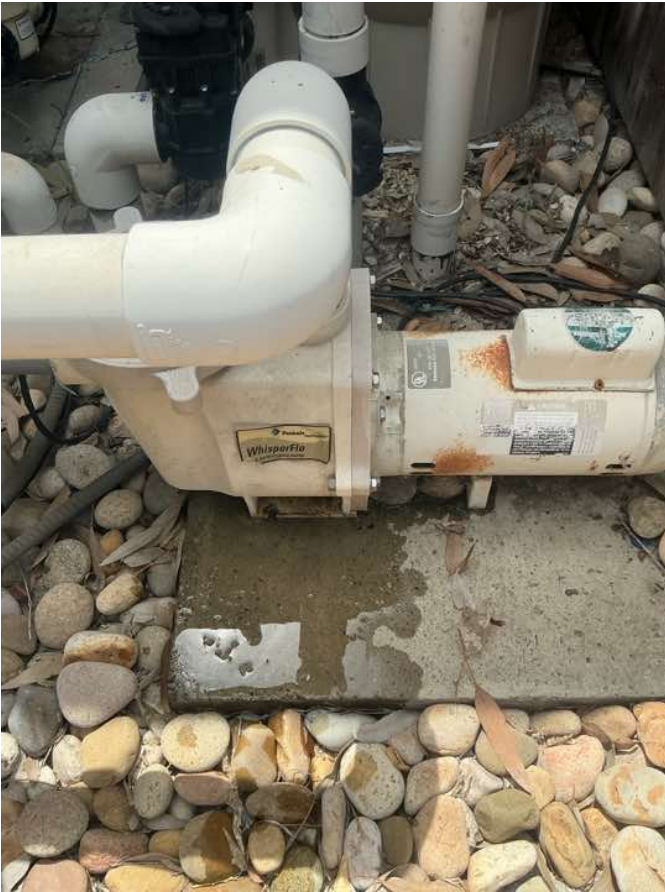
**MED 191:** Water leaks were observed at the pump. We recommend contacting a qualified contractor for repairs.

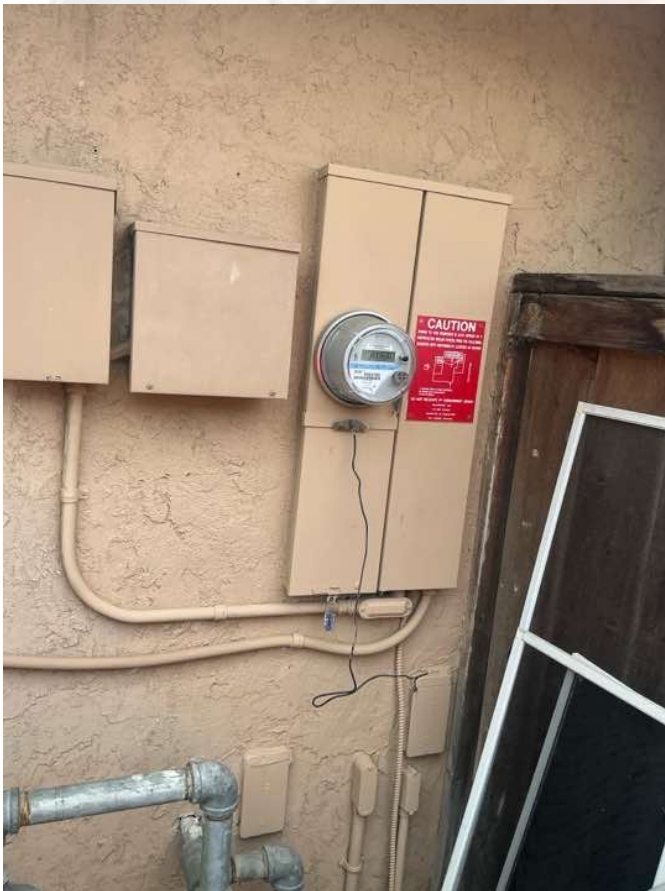
## **ELECTRIC METER**

**1:** The meter and main electrical service panel are outside on the left side of the building.

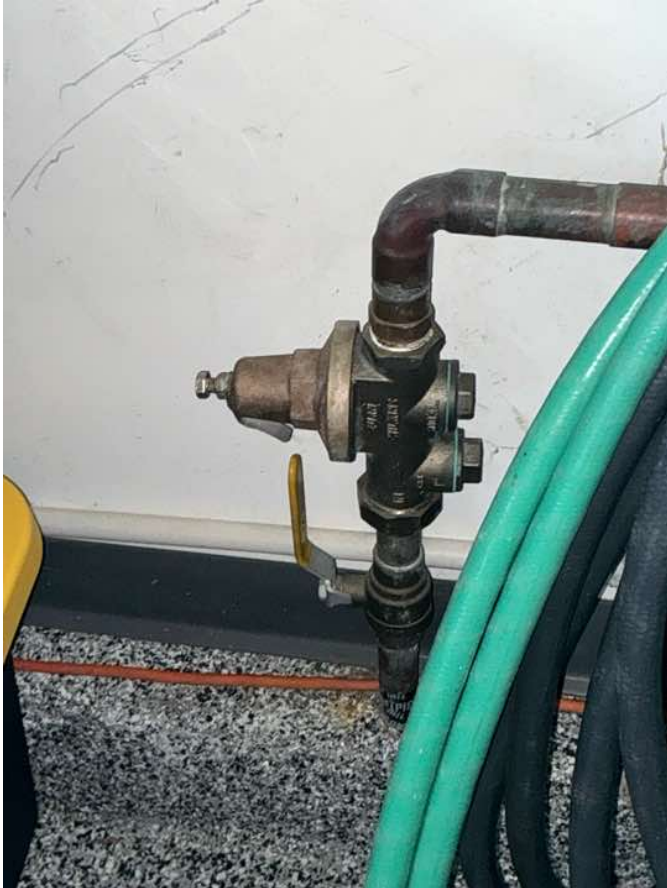
**WATER SHUTOFF LOCATION  
PLUMBING**

**5:** The domestic water supply shut-off valve is in the garage.

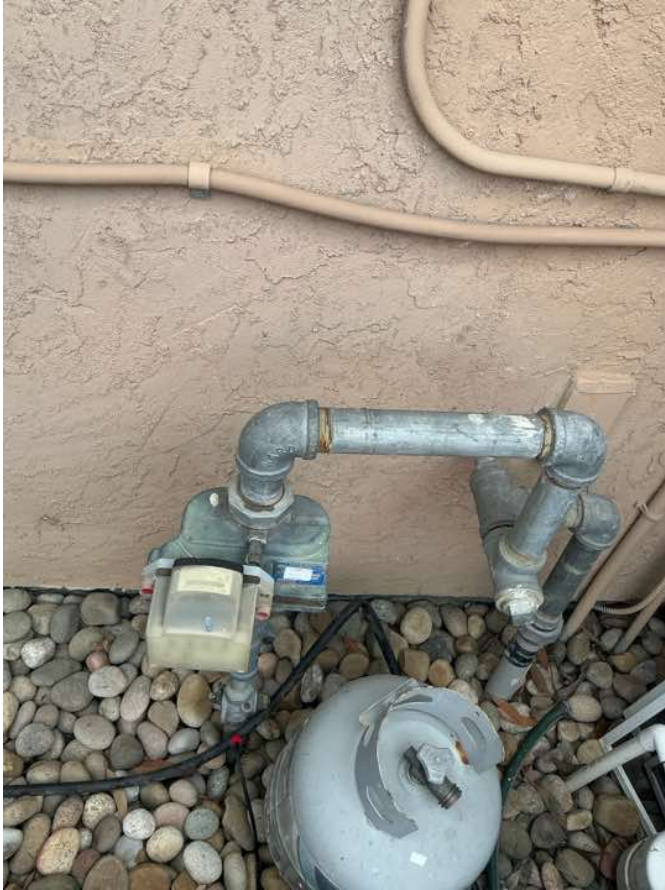
## **GAS METER LOCATION**

**6:** The gas meter is outside on the left side of the building. The main gas supply shutoff valve is located on the riser pipe between the ground and the meter. This valve should be turned 90 degrees (either way) in order to shut off the gas.
